# HERITAGE IMPACT ASSESSMENT

18667 MISSISSAUGA ROAD, TOWN OF CALEDON,  
REGIONAL MUNICIPALITY OF PEEL, ONTARIO

PROJECT NO.: OCUL2216  
DATE: JULY 28, 2023

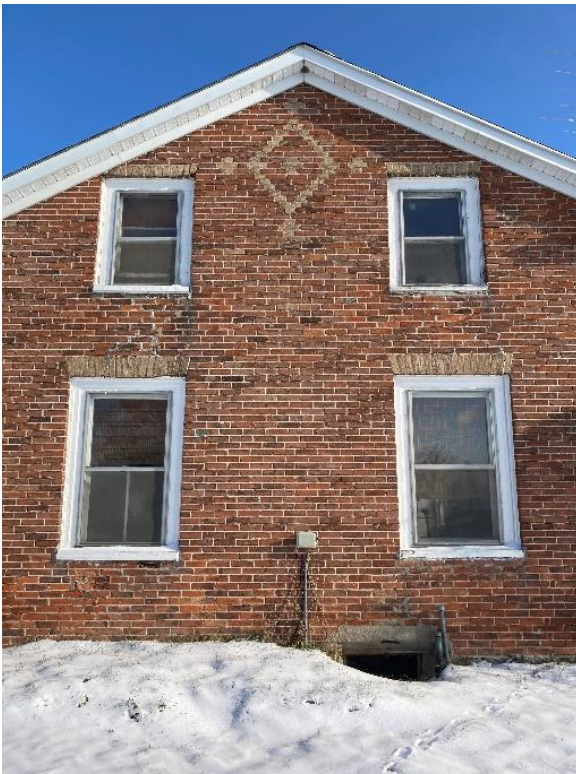
**Plate 17: South elevation of main block**

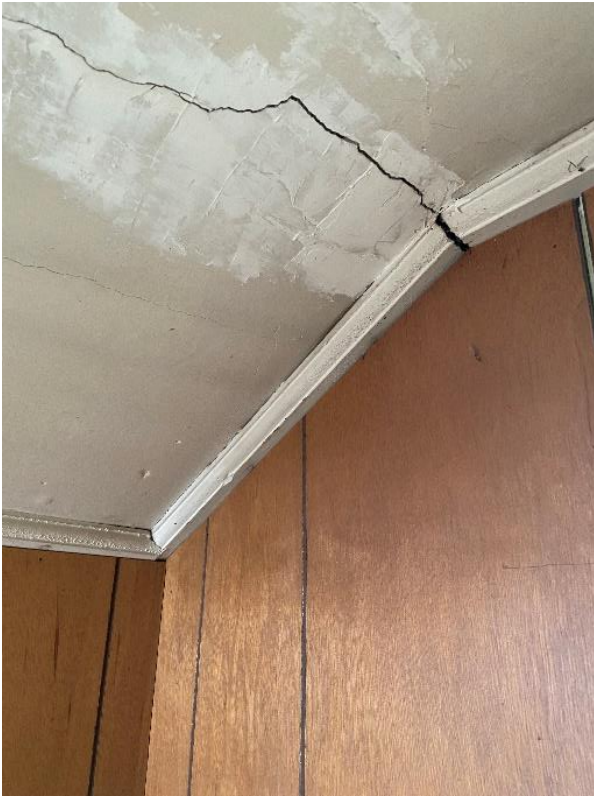
The southeast room is decorated with faux wood panelling and wallpaper on the walls and carpet over linoleum flooring (Plate 48). Both windows (of the north and west elevations) appear to be original and in good condition (Plate 49 and Plate 50). Cracks and subsequent repairs are evident in the plaster of the ceiling (Plate 53).

**Plate 53: Cracks and repairs of southeast room**

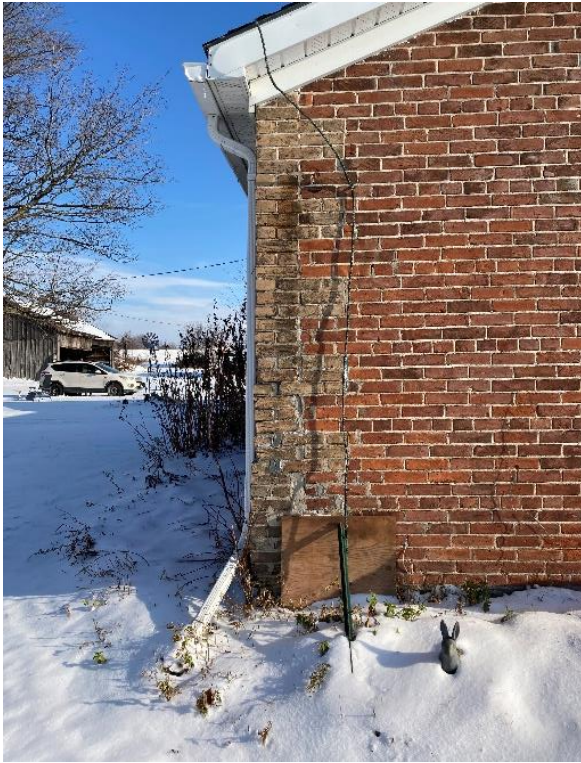
**Plate 64: Detail of southwest corner, showing quoins**

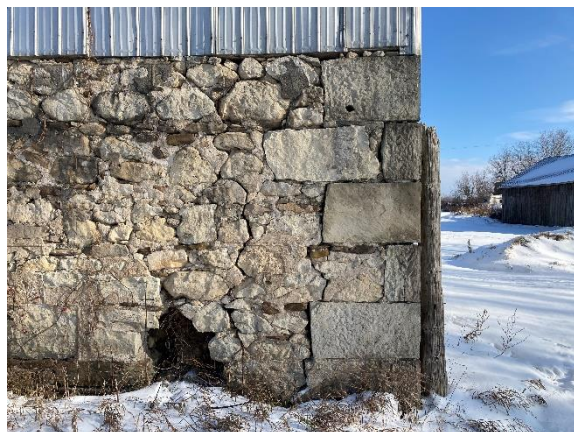
**Plate 92: Foundation and cut stone cornerstones of south barn**

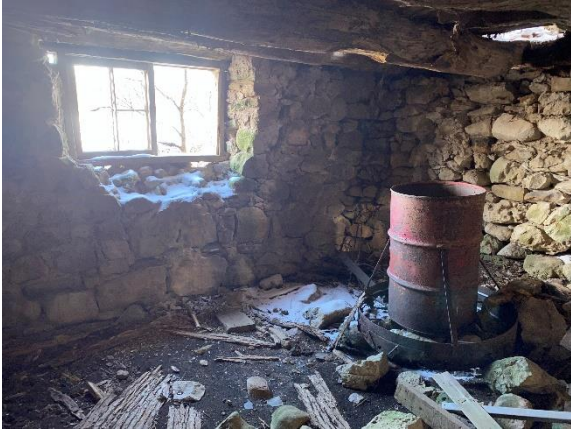
**Plate 93: North barn interior showing rubble stone foundations**
