# HERITAGE IMPACT ASSESSMENT

18501 MISSISSAUGA ROAD, TOWN OF CALEDON,  
REGIONAL MUNICIPALITY OF PEEL, ONTARIO

JULY 28, 2023

PROJECT NO.: OCUL2216  
DATE: JULY 28, 2023

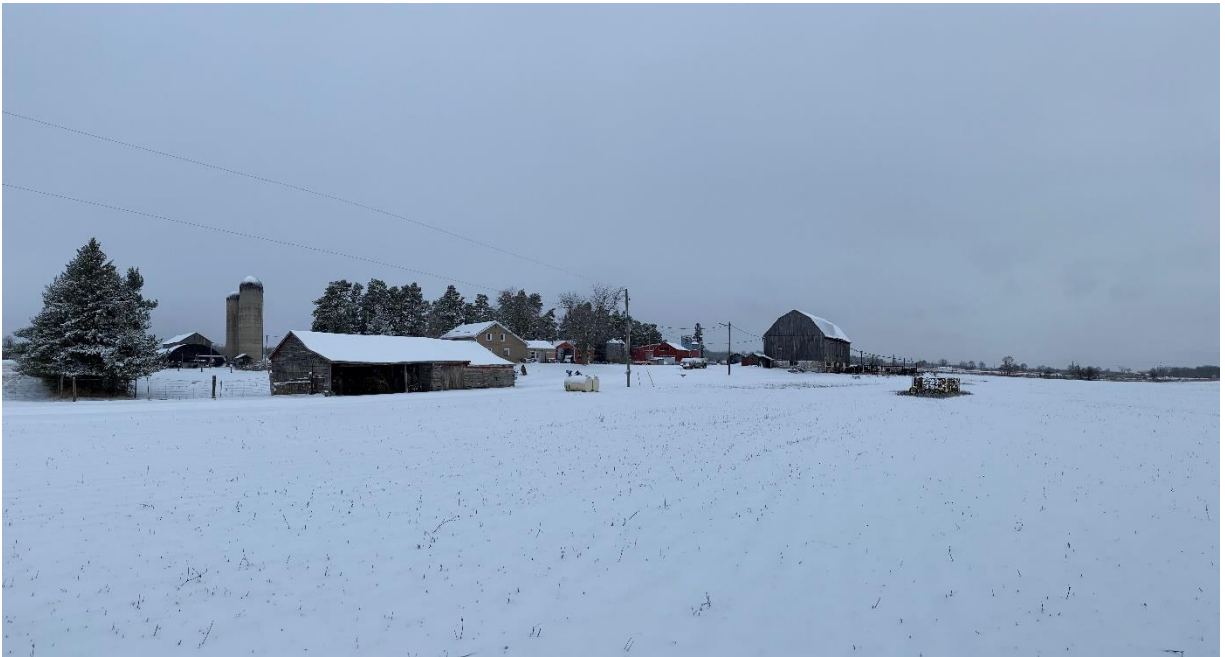
**Plate 4: Study Area at 18501 Mississauga Road.**

The approximately 50-acre Study Area features the original farmhouse complex built for Lot 16 including a farmhouse, two barns, six outbuildings, and eight silos (Figure 10 and Plate 4).

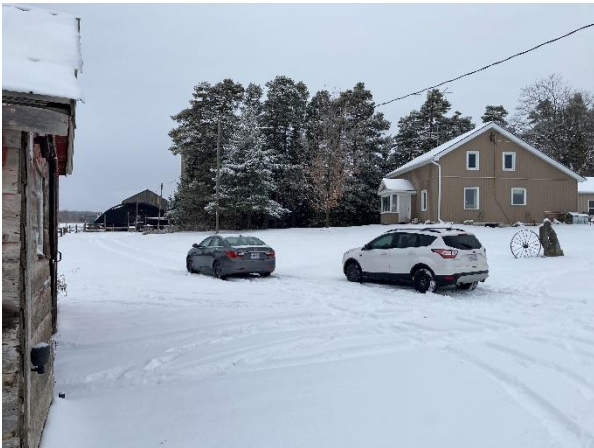
**Plate 5: View from the driveway towards the farmhouse, mature vegetative windbreak, and barn.**

The farmhouse is accessed from Mississauga Road by a long, winding, gravel driveway which leads to the central building complex (Plate 5). Circulation routes extend from the driveway, throughout the complex, connecting each of the outbuildings and the agricultural fields. Two mature coniferous tree stands act as windbreaks for the farm complex (Plate 6). One tree stand extends parallel to Mississauga Road, oriented approximately northwest to southeast, positioned as the southwest boundary of the building complex. Imagery from 2004 shows this row as recently planted. The second row is oriented perpendicular to Mississauga Road, oriented approximately northeast to southwest, extending along the northwest boundary of the main residence and the northernmost outbuildings. This stand appears to include a mix of mature and young conifers. Hedgerows and treelines also delineate the agricultural fields within the Study Area. These agricultural fields appear to be typical of those found in southwestern Ontario and do not have unique attributes associated with them (Plate 7).

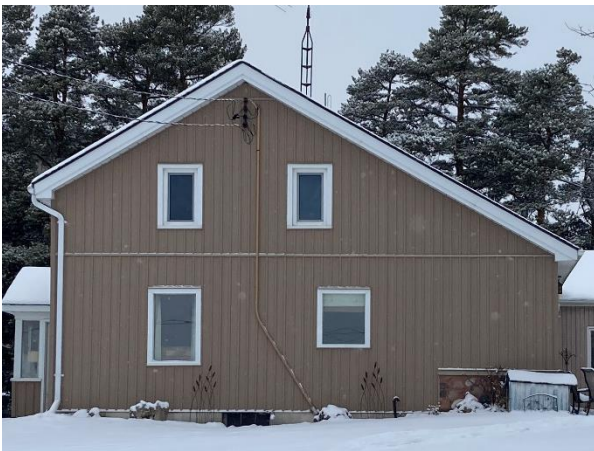
**Plate 13: South elevation.**

The south elevation features the gable end of the main block has two main floor windows and two second floor windows (Plate 13 and Plate 14). All four windows of this elevation appear to be new replacements. The window closest to the addition on the main floor is slightly offset, disrupting the symmetry of the fenestration, more commonly seen in early vernacular houses. The limit of the main block of the house can be identified on this elevation where the field stone veneer wainscoting of the addition ends.

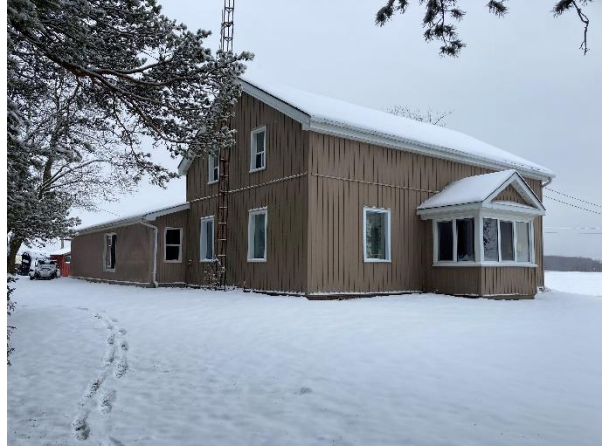
**Plate 16: North and west elevations**

The west elevation features a rear entrance via a small, centrally located, enclosed porch, with one main floor window on either side (Plate 16 and Plate 17). The porch is fully enclosed with a pediment style roof, the same board and batten siding on the lower half, large windows on the upper half of all three elevations, and the entrance on the south elevation (Plate 18). The small porch provides access to what was originally the front entrance of the house. The west elevation is the original front façade of the structure.

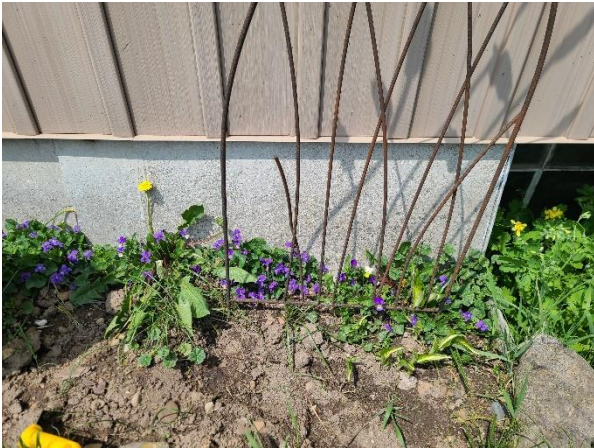
**Plate 19: Exterior foundation**

The original main block of the house is a one-and-a-half storey gable front house with a rectangular footprint. The house has a medium-pitched roof with boxed eave returns. The house has been reclad in new board-and-batten style vinyl siding. According to the tenant, the house was originally timber framed and clad with clapboard siding. In the early 19th century, the clapboard was removed and replaced with Insulbrick. In the mid-late 20th century the Insulbrick was removed and polyurethane spray foam insulation was applied followed by the extant board and batten style vinyl siding. The tenant went on to state that the main block foundation is constructed of fieldstone and that during the mid-late 20th century polyurethane spray foam insulation was applied to the foundation exterior

which was then clad in 3/8 inch concrete asbestos sheets that currently line the foundation (Plate 19 and Plate 20). Interior basement access confirmed the use of fieldstone and timber frames as original construction materials.

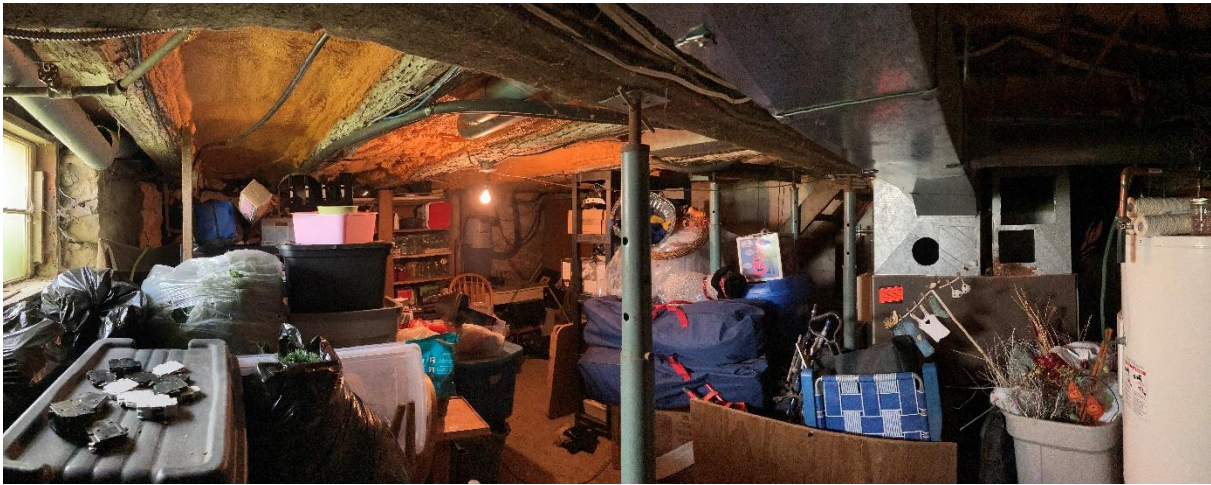
Plate 21: View of basement from southeast corner

An unfinished basement is accessed from a central staircase. The basement is a rectangular shape that encompasses the footprint of the main block however only the southern half of the basement is accessible while the northern half is a dirt crawl space (Plate 21 and Plate 22). The basement walls are the exposed parged fieldstone foundation of the main block (Plate 23) and the flooring is poured concrete. On the south wall there is a six-pane fixed window set into the foundation walls. The window has a wooden frame, sill, and muntins (Plate 24). There are four visible hand-hewn timber floor joists running east-west across the main block. The timbers have been adzed on the bottom, and presumably the top as well, and the original bark remains on the sides (Plate 25). Polyurethane spray foam insulation has been applied between the timbers. A singular machine cut squared timber floor joist runs north-south along the eastern edge of the basement (Plate 26). This squared floor joist is supported by a metal jack. The tenant stated that the squared floor joist was added in the early-mid 20th century after the original timber floor joists were cut to make room for the furnace duct work.

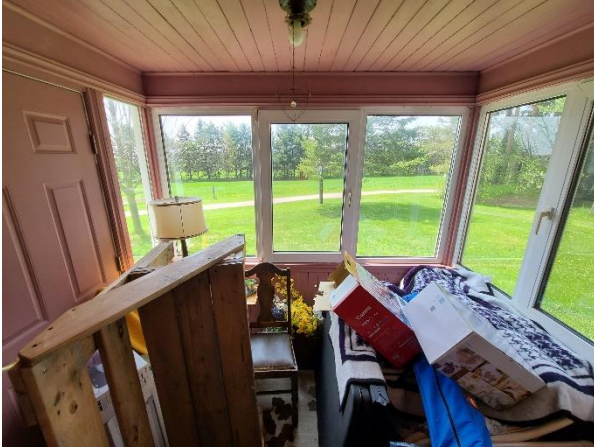
**Plate 27: Enclosed front porch on west elevation**

The original entrance to the main block of the house is located on the west elevation of the building. A small enclosed porch has been built in the mid-late 20th century that encompasses the original front door (Plate 27). The original front door is a simple rectangular wooden design demonstrative of a vernacular interpretation of Georgian and Neoclassical styles (Plate 28). There are two vertical five-pane fixed windows flanking the entranceway. The main block is arranged in a central hall plan. Staircases to the basement and second storey are located on top of each other on an east/west axis running along the length of the main block (Plate 29). Living spaces are located north and

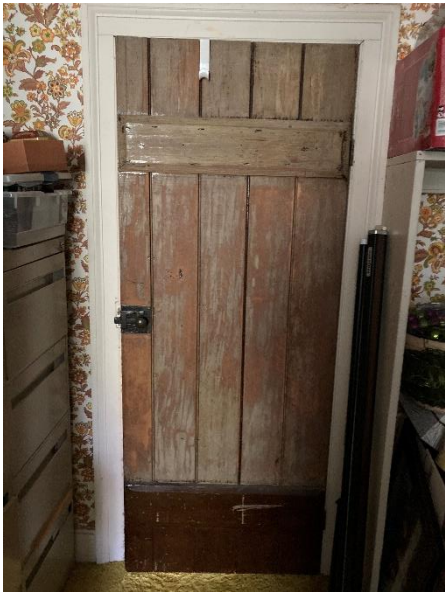
Plate 39: Original wood plank bedroom door

The second storey is accessed from the central stairwell and leads to a landing and central hallway that runs parallel to the stairwell along its south (Plate 33). At the top of the stairwell is a bathroom (Plate 34). There are four bedrooms located on the second story (Plate 35 to Plate 38). Two to the north of the stairwell and two to the south. Each bedroom features a singular window and sloping roof reflecting the one-and-a-half story massing of the main block. Some bedroom doors and hardware appear to be original. The window frames have late-20th to early-21st century plastic frames but are set inside older wood frames (Plate 39 and Plate 40).

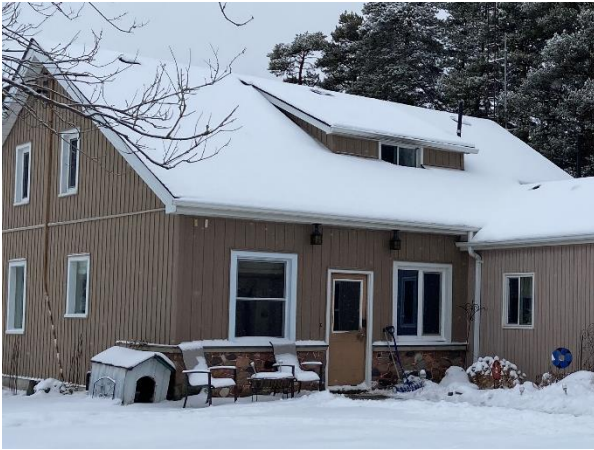
**Plate 44: Main entrance on east elevation.**

The one storey entryway addition on the east elevation of the main block features a central entryway door flanked by a new hung window on the south and a casement window on the north (Plate 44 and Plate 45). The addition is clad in the same board-and-batten siding as the main block and includes a fieldstone veneer wainscoting wrapping around the lower half, indicating where the addition meets the original main block (on the south elevation) (Plate 46). The roofline of this addition includes a shed dormer, expanding the second floor of the house as well, likely contemporaneous with the entryway addition. The tenant stated that this addition was constructed in the mid 20th century. Currently this entryway addition is used as mud room shared between the main block and the east addition

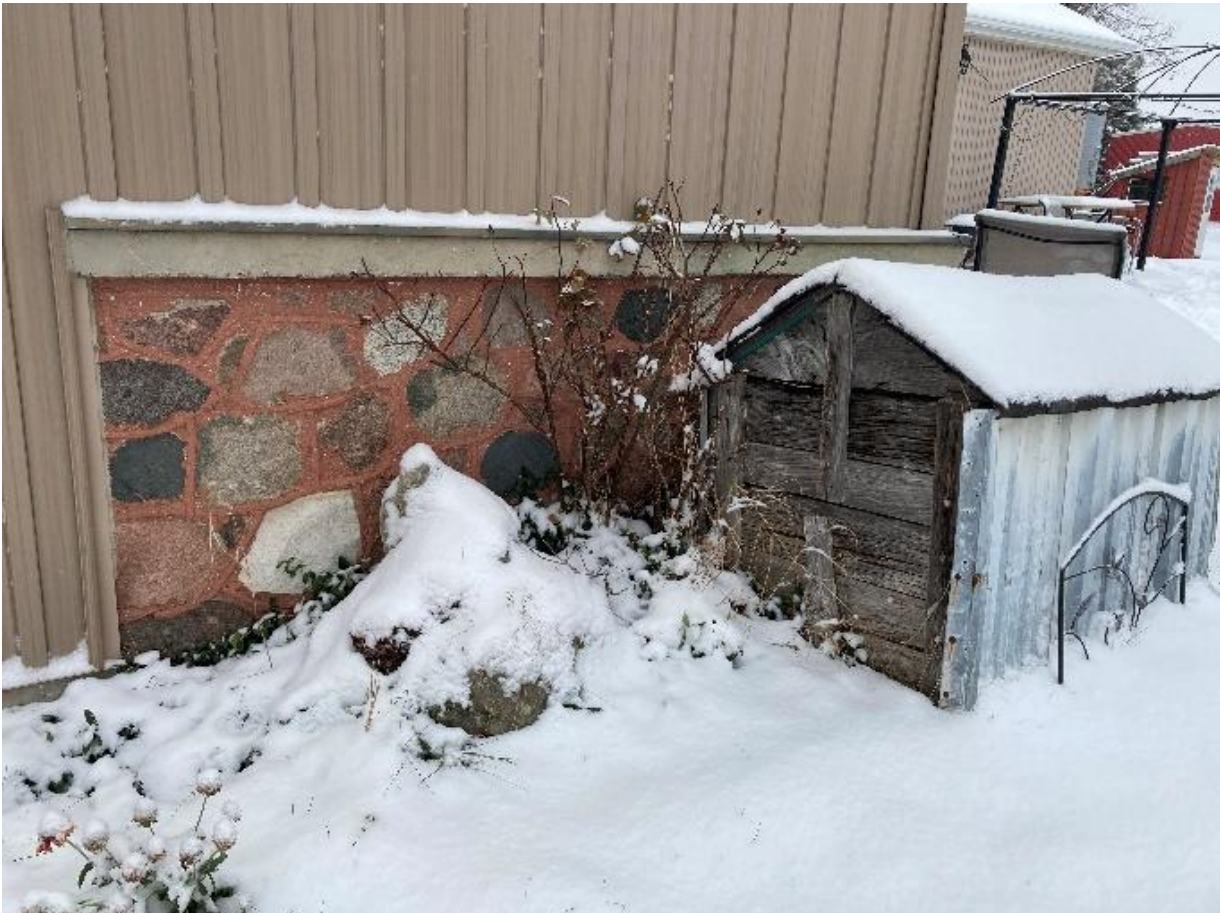
**Plate 46: Fieldstone veneer indicating the limit of porch addition on main block.**

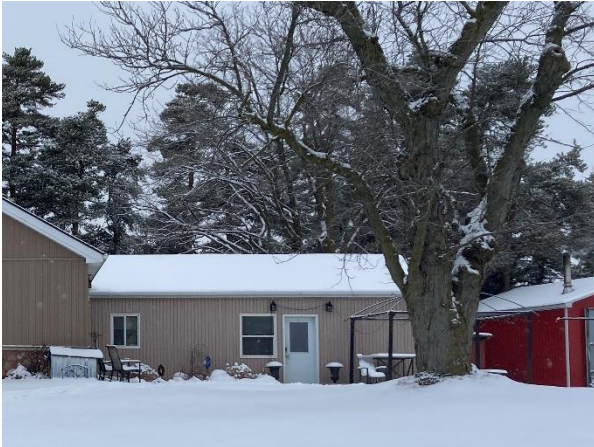
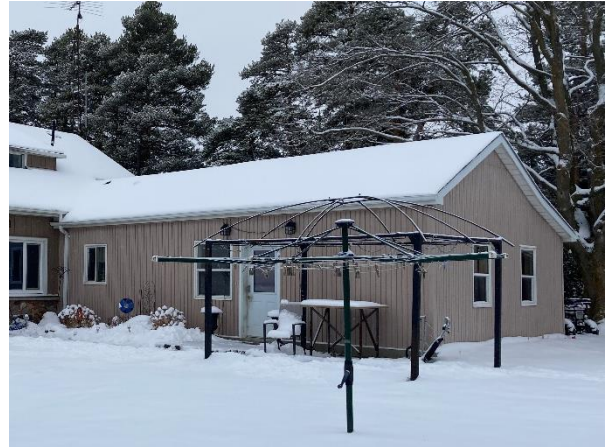
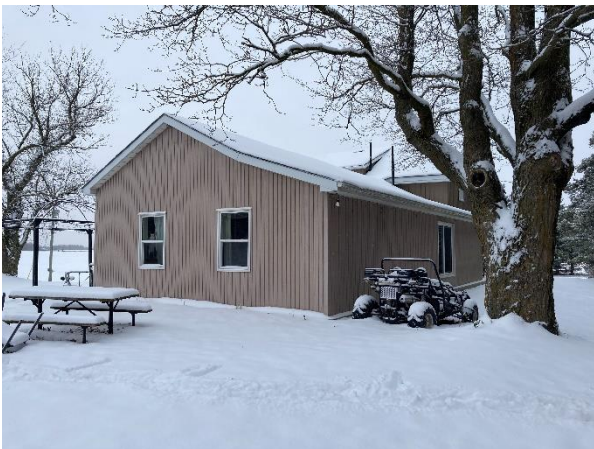
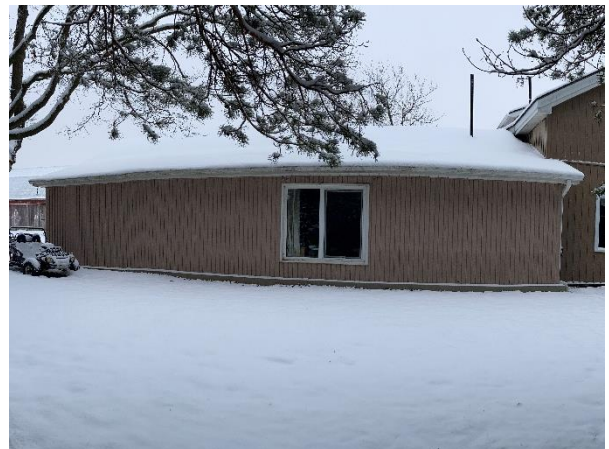
A second addition on the east elevation extends perpendicular to the original main block and has a rectangular footprint, concrete slab footing, and a gable roof with a small extension on the north elevation of the addition (Plate 47 to Plate 50). The addition connects to the north portion of the east elevation of the original main block and the north limit of the entryway addition. This addition is accessed via an entrance on the south elevation and features new vinyl or aluminum sheet siding, matching in colour to the board and batten style siding of the rest of the house, and new sliding or hung windows on all elevations. The tenant reported that the east addition was constructed in the mid to late 20th century. Currently the east addition is being used as a separate dwelling.

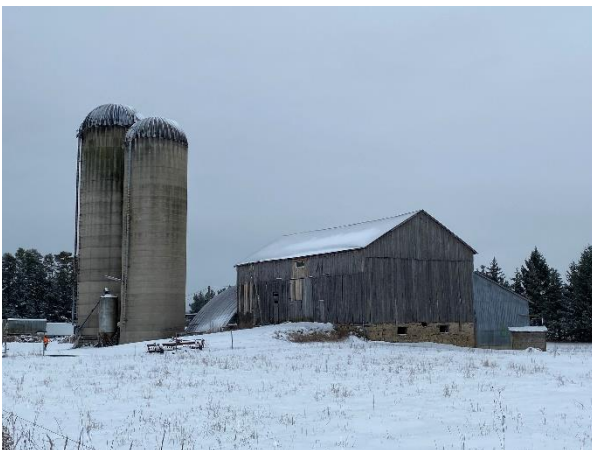
**Plate 51: North and west elevation of Barn No. 1.**

Barn No. 1 is located to the northwest of the main complex, outside of the northeast-southwest vegetative windbreak. This barn is part of a smaller complex within the main building complex that includes two concrete silos, a steel Quonset addition on the southeast elevation of the barn, and a corrugated metal clad addition with a saltbox roof on the southwest elevation (Plate 51). The barn features field stone foundations and a gable roof and, although the interior was not accessed due to safety concerns, timber framing was observed through holes in the wood plank siding (Plate 52).

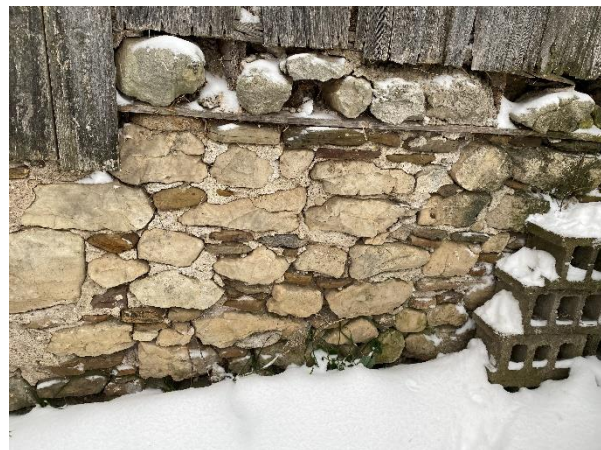
**Plate 52: Detail of Barn No. 1 fieldstone foundations.**

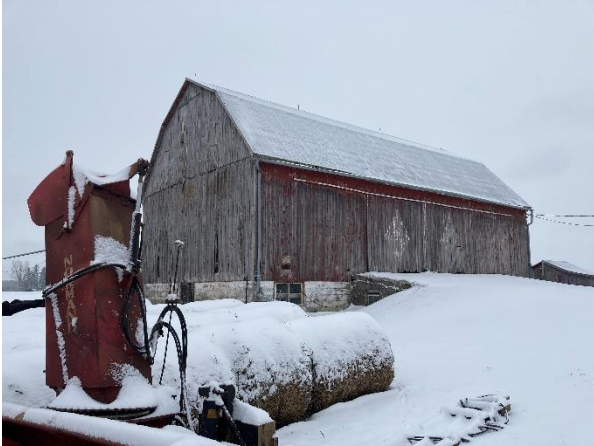
**Plate 53: North and west elevation of Barn No. 2.**

Barn No. 2 sits atop poured concrete foundations, with wood plank siding, and a metal gambrel roof (Plate 53 to Plate 55). The built-up ramp on the east elevation is supported by concrete wingwalls. One fixed window is contained within the north wall of the ramp, with a wooden sill, frame, and muntins. Three wood framed window openings into the stables extend along the length of the west elevations, flanked by two former entryways to the stables, now boarded (Plate 56 to Plate 57). These openings are all missing their windows. One window is present on each of the remaining three elevations. The barn has been painted red, which is faded and peeling but still visible. Two large white painted diamond shapes decorate the sliding doors at the top of the ramp (Plate 58). Both Barn No. 1 and 2 are currently in use.

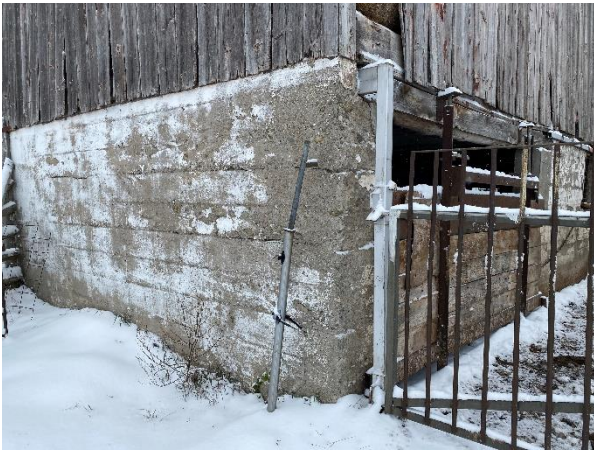
**Plate 55: Concrete foundation of Barn No. 2.**

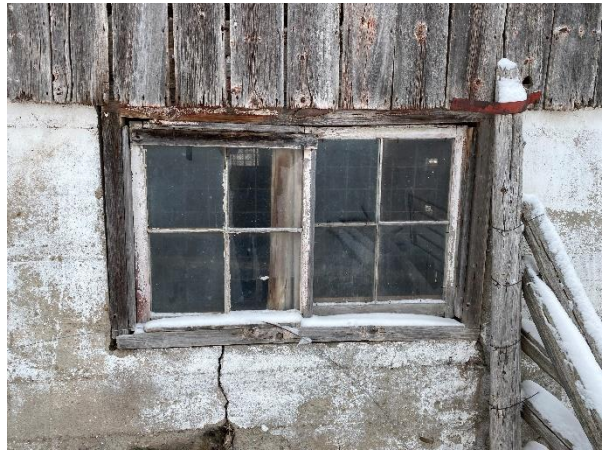
**Plate 56: Barn No. 2 window detail.**

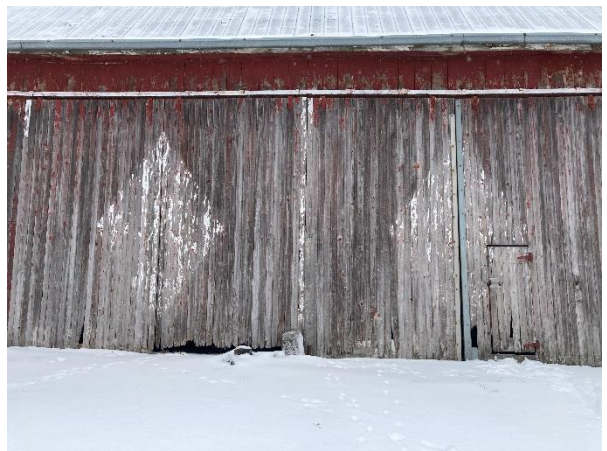
**Plate 58: Painted diamond pattern on east elevation ramp doors of Barn No. 2.**

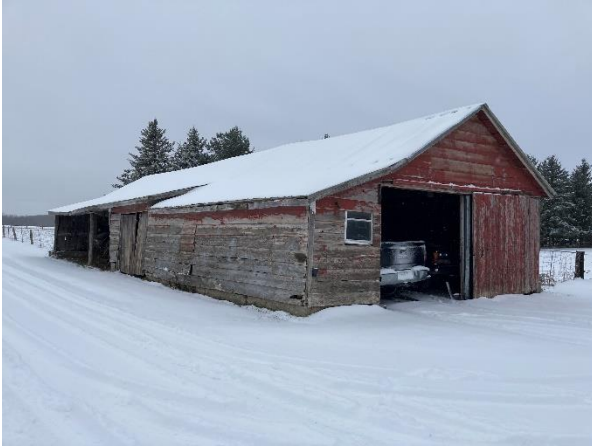
Plate 59: North and east elevation of Outbuilding No. 1.

Outbuilding No. 1 is the southern most building of the complex. This wood drive shed is located at the top of the driveway, to the south of the residence. This wood drive shed features a metal saltbox style roof and concrete foundations (Plate 59).

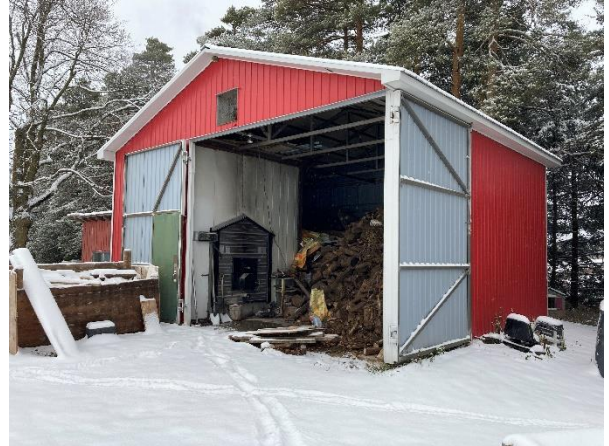
Plate 60: Outbuilding No. 2.

Outbuilding No. 2 is located to the north of the residence, between the house and Outbuilding No. 3. This small aluminum prefabricated shed has a gable roof and large, barn style, doors, built atop a poured concrete pad (Plate 60).

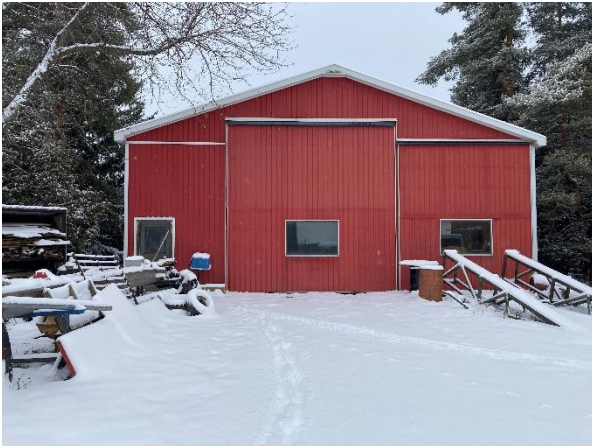
Plate 61: Outbuilding No. 3.

Outbuilding No. 3 is located to the north of Outbuilding No. 2, between Outbuildings No. 2 and 4. This large aluminum shed features a gable roof and is constructed on a poured concrete pad (Plate 61).

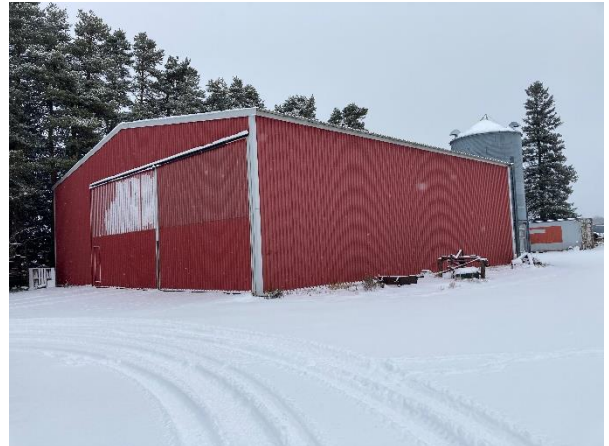
Plate 62: Outbuilding No. 4.

Outbuilding No. 4 is the northernmost building of the complex, located to the northwest of Outbuilding No. 5. This large aluminum shed features a gable roof and is constructed on a poured concrete pad (Plate 62). A metal silo is located at the rear, on the northeast side.

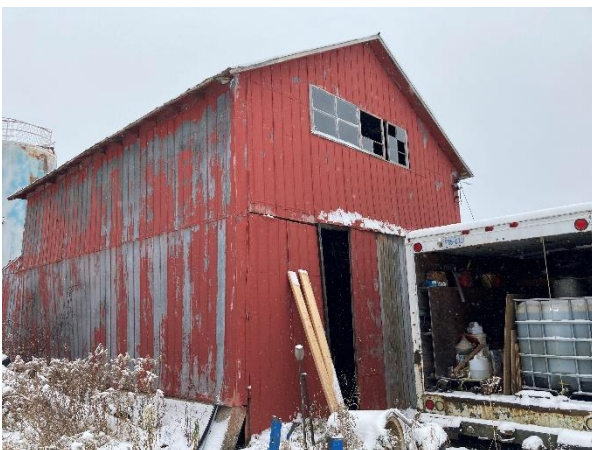
Plate 63: Outbuilding No. 5.

Outbuilding No. 5 is located to the north of Outbuilding No. 3, between Outbuildings No. 3 and 4. This wood shed features a gable roof and a small addition on the rear (Plate 63). A metal silo is located at the rear, on the northeast side.

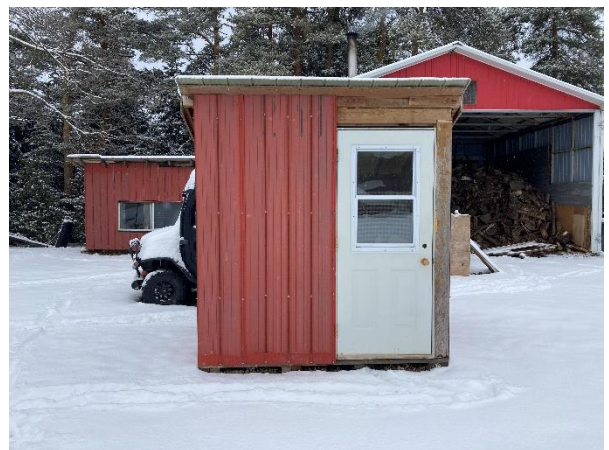
Plate 64: Frame shed

A small frame shed is located to the north of the residence (Plate 64). This shed is of 2x4 frame construction with plywood and aluminum siding and a saltbox style roof. The shed is supported by a wood frame base.

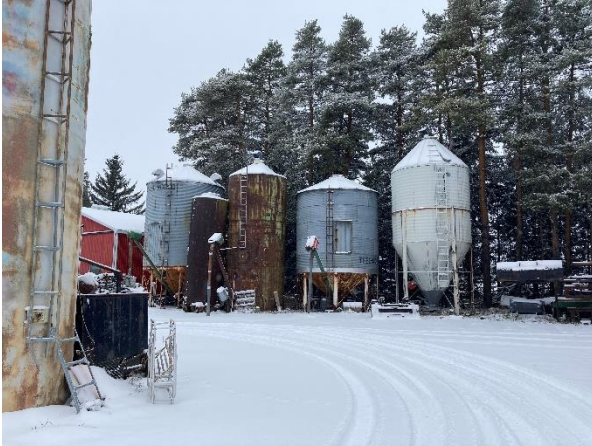
**Plate 65: Additional silos between Outbuildings No. 3 and 4.**

Four additional silos are located between Outbuildings No. 3 and 4 (Plate 65). The Study Area also includes a number of temporary structures (chicken coops and storage structures) which are recent additions to the property.

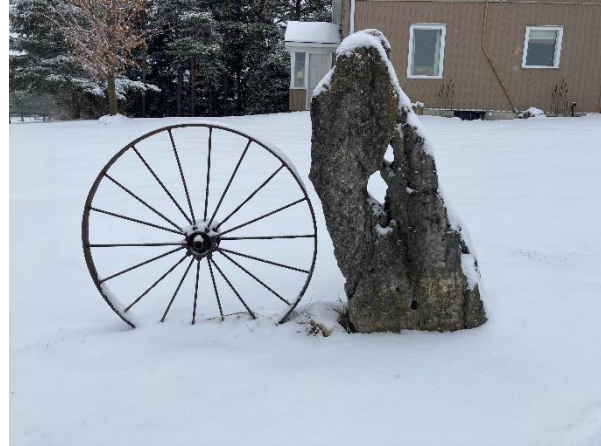
**Plate 66: Wagon wheel and stone feature.**

A wagon wheel and upright placed stone are positioned together at the top of the driveway, to the south of the house (Plate 66).
