# HERITAGE IMPACT ASSESSMENT

1420 CHARLESTON SIDEROAD, TOWN OF CALEDON,  
REGIONAL MUNICIPALITY OF PEEL, ONTARIO

PROJECT NO.: OCUL2216  
DATE: JULY 28, 2023

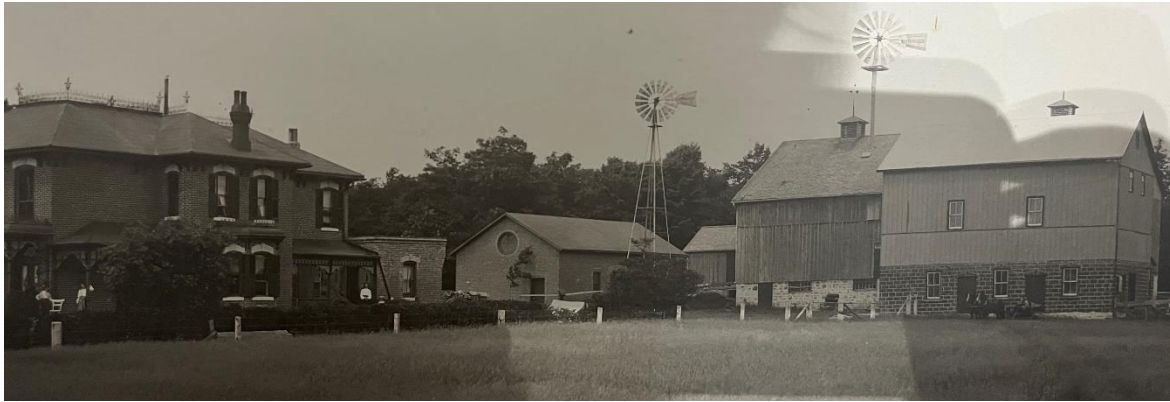
An undated photograph of the farm complex shows the house and several outbuildings, likely during the first decade of the 20th century (Plate 1). The two-storey brick house is seen as fully constructed, including a rear tail or summer kitchen. To the rear of the house is a single storey brick building with a gable roof and circular gable window. The stone foundation barn is partially visible at the rear of the property, clad with wood and featuring a gable roof with two cupolas and a weathervane. A smaller timber framed structure is seen in the background, between the barn and the brick outbuilding which appears to be of the same style and construction as the barn. It is unclear if this structure is freestanding or part of the barn. Obscuring the barn, to the north of the house, is a two-storey carriage house with stone foundations, brick masonry on the ground floor, likely load bearing, and the upper storey clad in wood, with a gable roof. The windows of the ground floor are accented with stone segmental arch heads and lug sills.

Plate 1: Historical photograph of the house and outbuildings, date unknown.

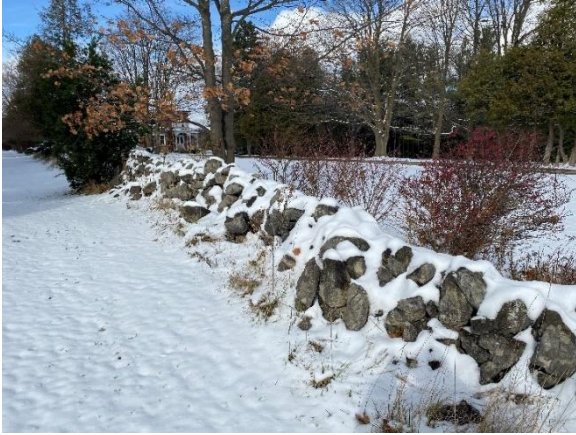
**Plate 9: Low fieldstone wall along the southwest side of the Study Area**

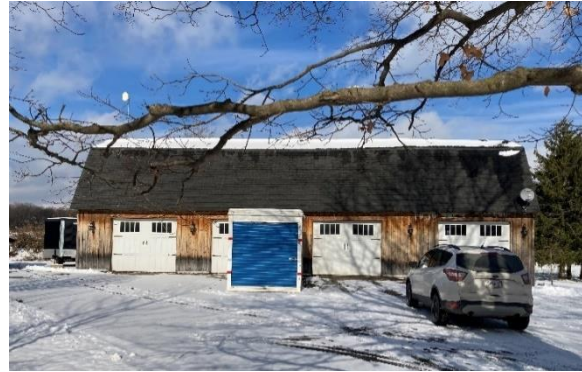
An outbuilding at the rear of the Study Area is northwest of the house. It is oriented east-west and is wood clad with a gambrel roof (Plate 10). Based on aerial photographs and topographic mapping this building was constructed between 1973 and 1994 (Figure 8 to Figure 9).

**Plate 10: Late 20<sup>th</sup>-century outbuilding**

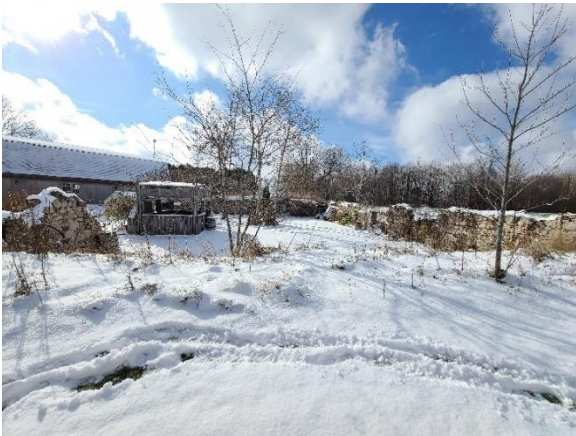
The parged fieldstone ruins of an earlier barn are also located at the rear of the Study Area and oriented approximately northeast-southwest along the northwest boundary (Plate 11). Etched into the parging is “H.R.C./J.H.C./MAYS(?)/190\_/8\_”, likely the initials of John H. Cameron (J.H.C.) and Hilton R. Cameron (H.R.C.) who would have been children at this time (Plate 12). It could not be determined whether this etching is part of the original construction or a later repair. It was noted during the site visit that a wooden covered area has been added to the ruins, featuring red brick flooring. This barn is visible in the early 20th-century photograph that shows the barn as a timber frame structure with a gable roof (Plate 1). Gable roofed barns are often earlier than those build with a gambrel roof, although in this case we know from the engraving that the barn dates to the first decade of the 20th century, at the latest (McIlwraith 1997).

**Plate 11: Barn foundation ruins, looking southwest**

- 4 A heritage documentation plan shall be conducted for the property with a focus on the barn foundation ruins on the property.
- 5 Develop a Heritage Conservation Plan for the farmhouse prior to use of the farmhouse as office or laboratory space to guide the adaptive re-use efforts and outline how the heritage attributes of the structure will be conserved, protected, and enhanced during the rehabilitation program and into the future.

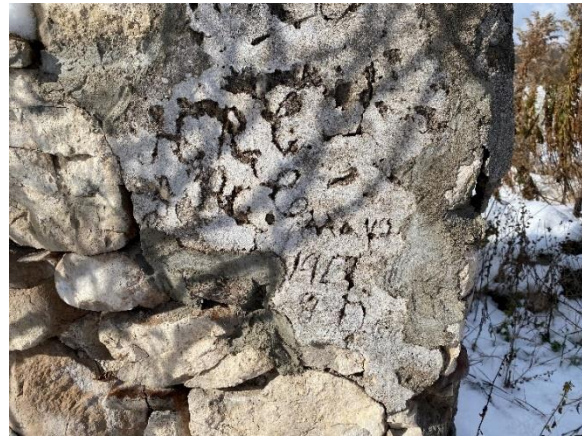
**Plate 12: Closeup of inscription on barn ruins**

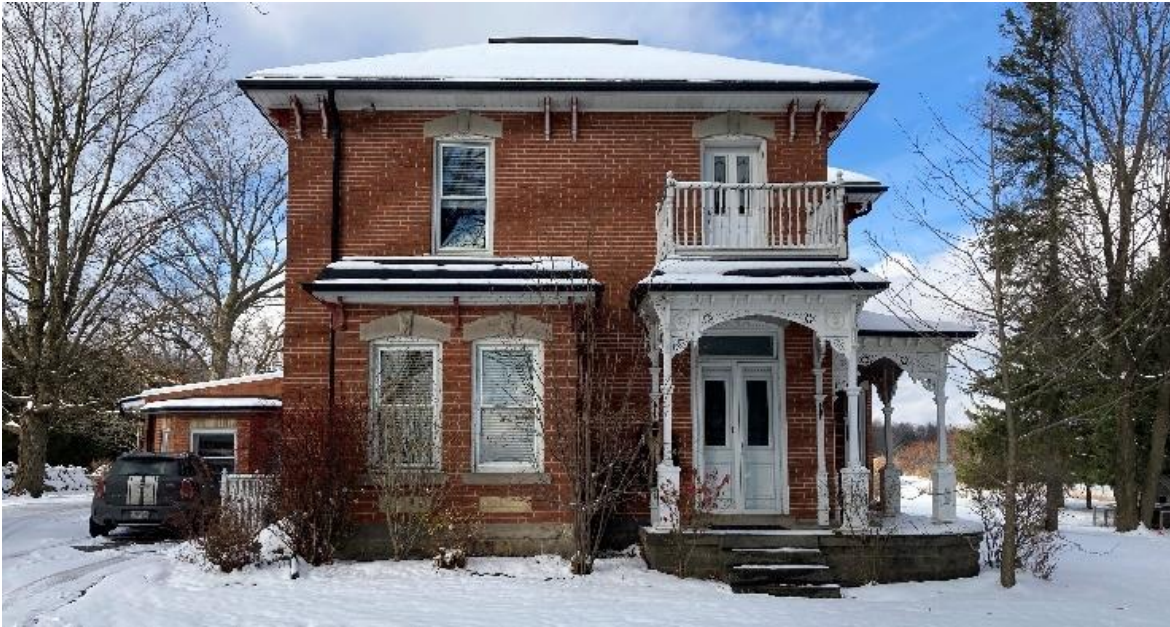
**Plate 13: South (front) elevation**

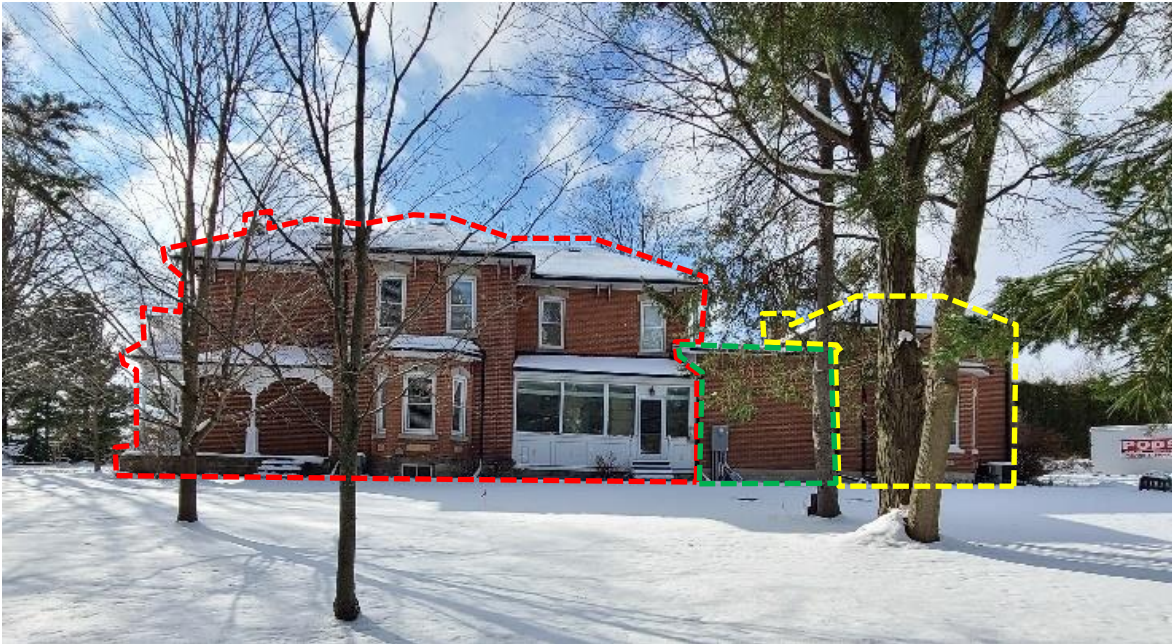
The farmhouse is composed of three elements: the original main block, a rear tail, and the rear and side addition on the north and west sides of the house. These are described individually in the following subsections. The four elevations of the structure are shown in Plate 13 to Plate 17. The house is oriented in a northwest to southeast fashion but for ease of description it is described in a north-south orientation where the south (front) elevation is on the southeast and the north (rear) elevation is on the northwest.

**Plate 14: East elevation showing the original house (outlined in red), rear tail (outlined in green) and rear/side addition (outlined in yellow)**

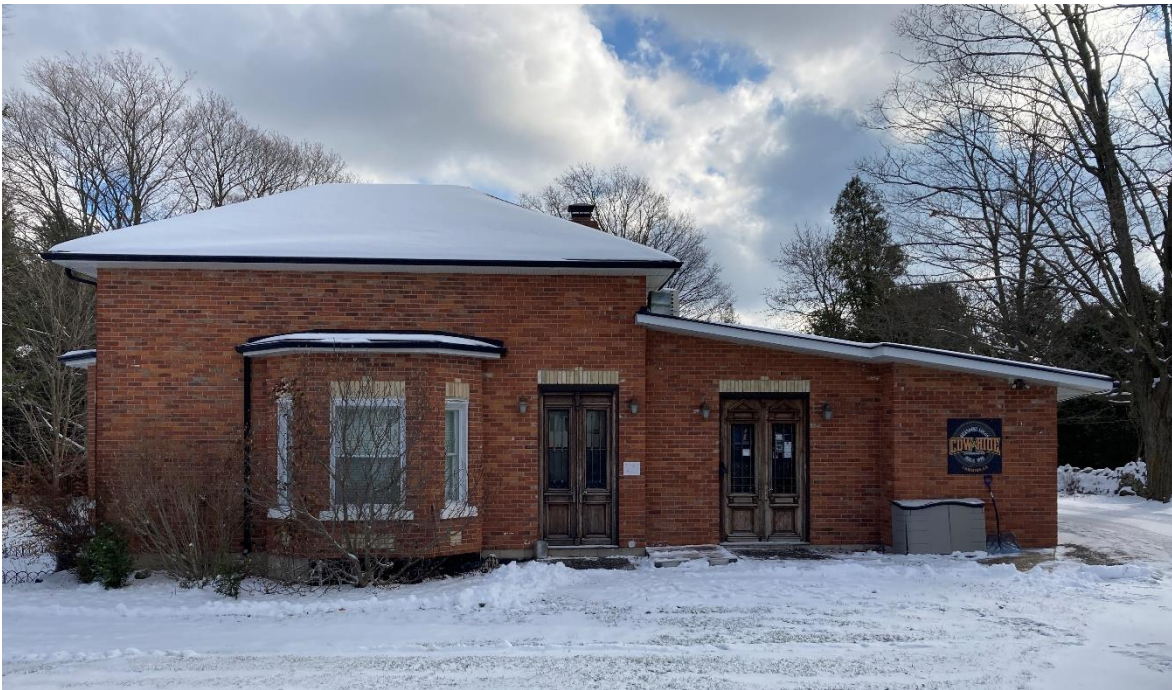
**Plate 15: North (rear) elevation**

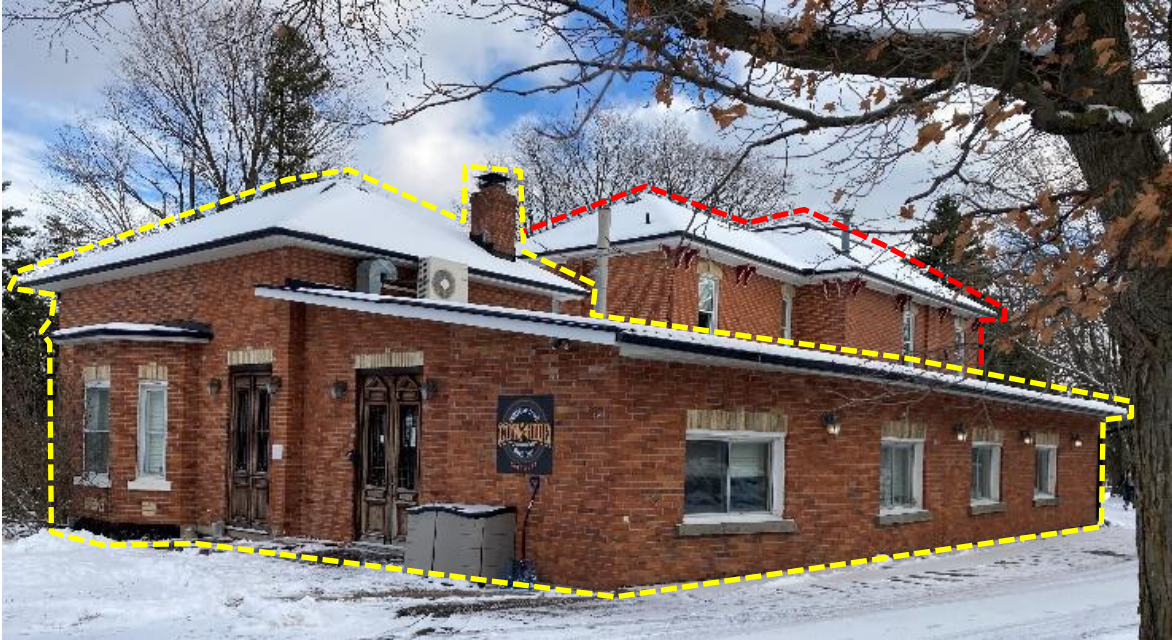
Plate 16: Oblique view of north and west elevations of rear and side additions (outlined in yellow, original main block is outlined in red)

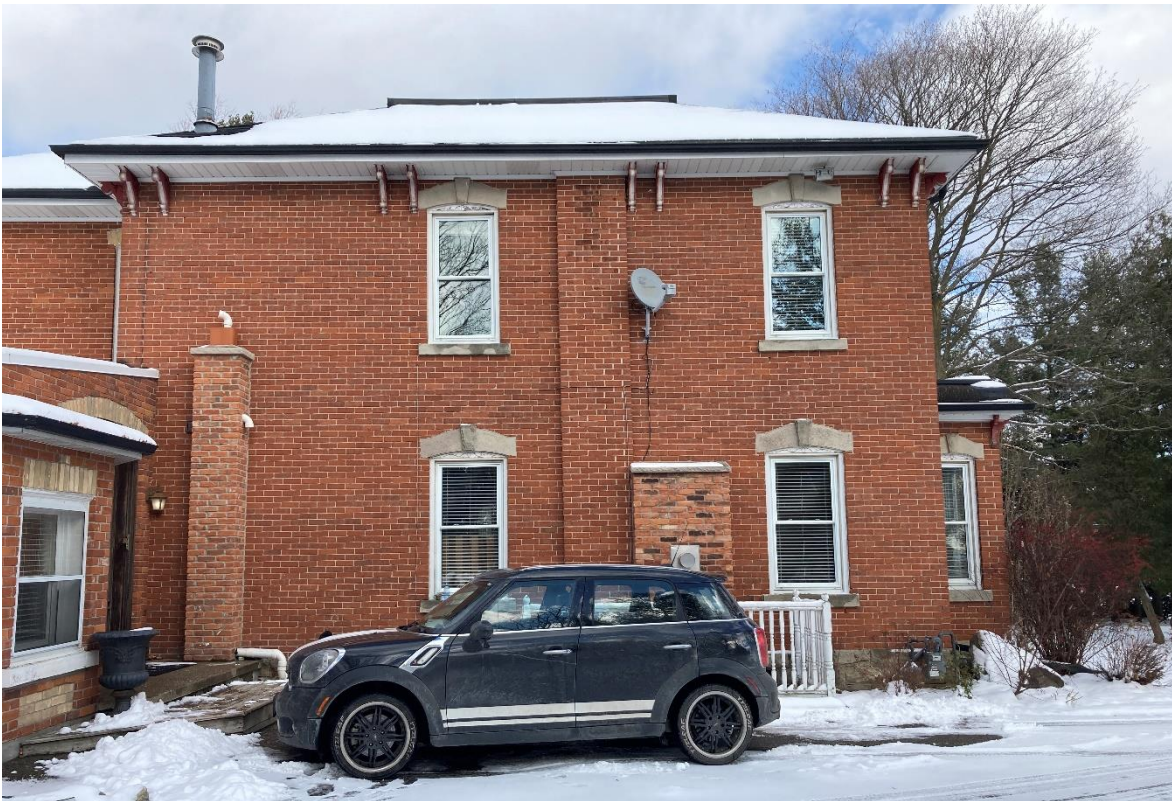
Plate 17: South portion of the west elevation of original main block

Plate 36) and now the west elevation features two external vents, extending the height of the first storey and constructed of brick masonry (Plate 17 and Plate 35). Neither date to the original construction of the main block.

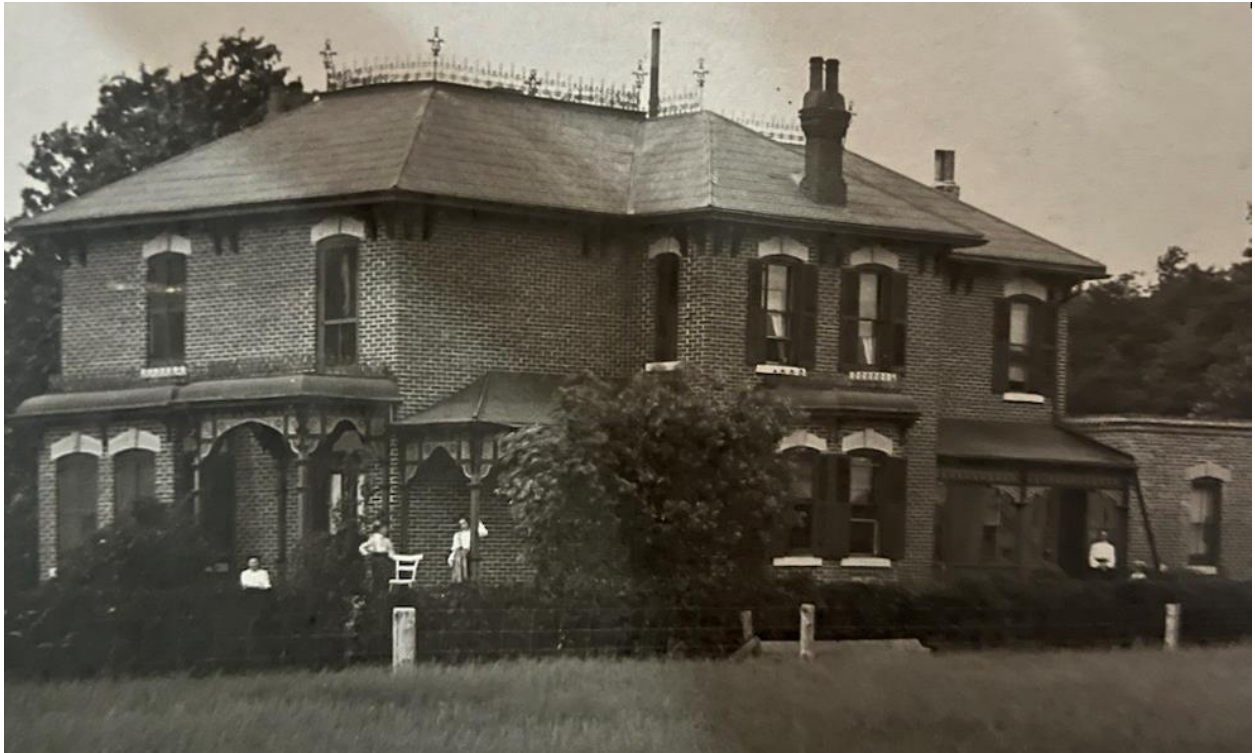
The historical photo of the house shows at least two chimneys on the main block. An internal chimney on the east elevation and the external chimney on the north elevation are no longer extant (compare Plate 18 to Plate 26 and to

**Plate 18: Detail of the late-19th to early 20th-century photograph of the house.**

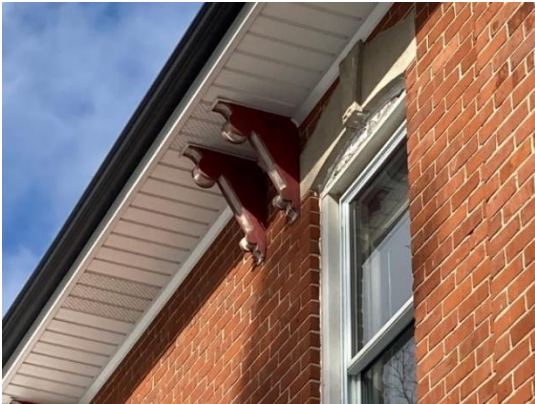
**Plate 19: Overhanging eaves and paired bracket detail**

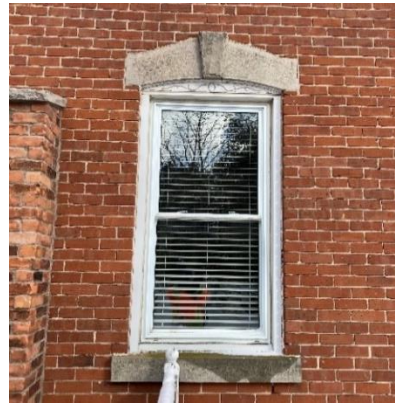
Contrasting with the red brick are the stone segmental arch heads and lug sills of the window and door openings. The stone heads have central and projecting "keystones" while the lug sills are bush hammered with chiselled margins (Plate 20). Generally, the windows of the main block are identical in style and materials except for the second storey windows on the west elevation, which have buff brick arched heads that appear to be a repair or replacement for the stone heads (Plate 34). Some windows were wood, double-hung and protected by storms, but others have been replaced in vinyl, including those at the foundation level on the west elevation. A 2022 home inspection report notes that some of the wood windows have not opened for many years and are seized (Home to Home Inspections Ltd. 2022).

**Plate 20: Main block window example**

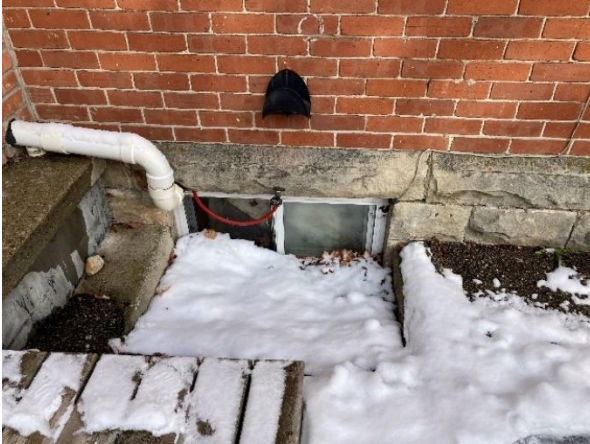
**Plate 21: Cut stone foundation**

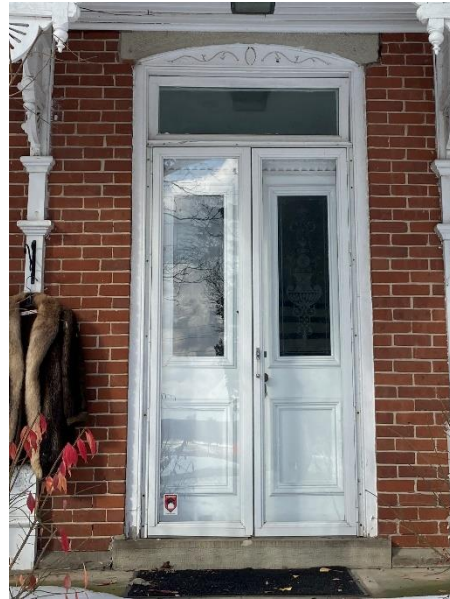
The main entrance on the south façade has a double door with flat transom (Plate 24). The doors are protected by double storms and hung within a wooden frame topped with the same decorative arched head and decorative stone arch and sills as the windows. Although the transom lights appears to date to the main block's original construction, it is likely that the double doors and storms are more recent replacements.

**Plate 24: Main entrance doorway**

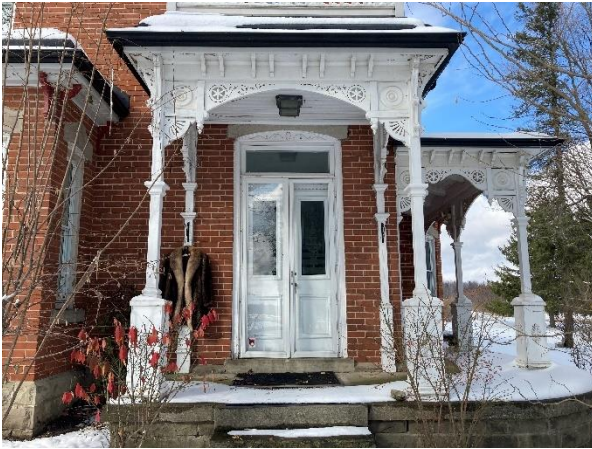
Access to the main entrance is via a porch that wraps around the south and east elevations, extending from the main entrance on the south elevation to the bay window of the east elevation (Plate 24). Its stone foundation is continuous and extends the length of the porch (Plate 25 to Plate 27). Two roofs cover the porch, one for the portion on the south elevation and one for the east elevation. The south porch has a mansard roof with second-storey door but, as the historical photo shows, this was originally a window (compare Plate 18 to Plate 13 and Plate 26). The east porch features a hipped roof, the underside of which is bellcast (Plate 28). Both porch roofs are accented with decorative paired brackets and supported by wooden arcades with square posts featuring decorative scrollwork and filigree accents (Plate 29 to Plate 30).

**Plate 25: Main entrance porch**

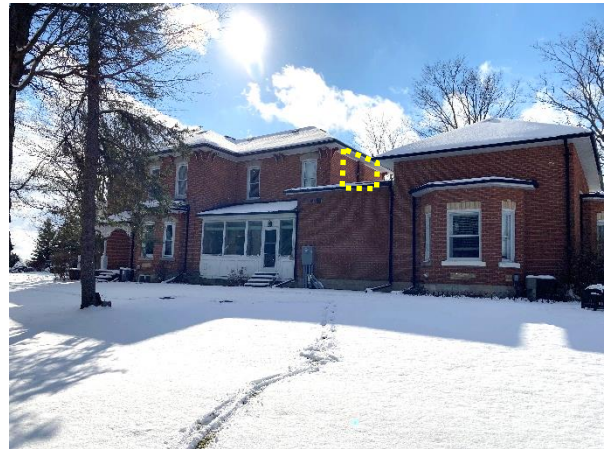
**Plate 36: East elevation with former external chimney visible on original main block (highlighted in yellow)**

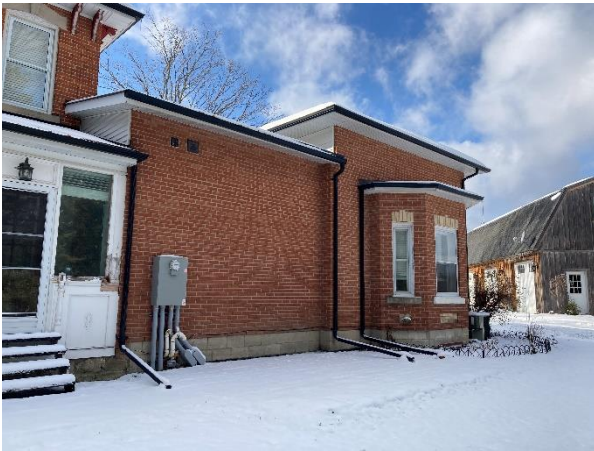
Connecting the north elevation of the main block to the rear and side addition is the one-storey rear tail (Plate 37). This is probably the same rear addition seen in the historical photo, but has been reclad and in-filled the east elevation window (Plate 18). The structure may have been a summer kitchen for the main block, and like the latter structure its the stretcher bond brickwork indicates either brick-clad frame or double-wythe brick walls connected with masonry ties.

**Plate 37: East elevation of rear tail**

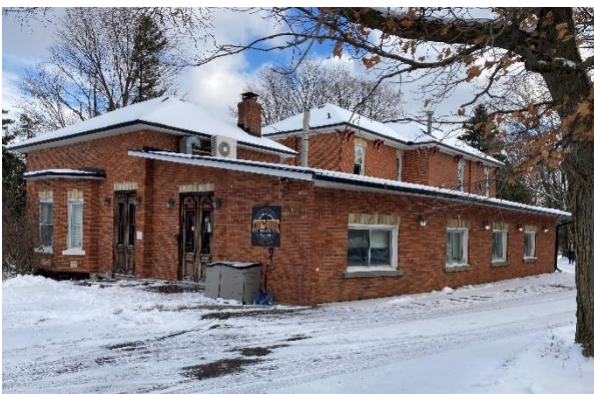
The rear and side addition is comprised of two segments, both built in red brick laid in stretcher bond on cement block foundations. Based on their similar style, materials, and condition, these rear and side structures were likely constructed at the same time and so are discussed together. The rear structure has a square footprint and hipped roof while the side portion has a shed roof and extends along the west sides of the rear addition, rear tail, and main block (Plate 38).

**Plate 38: Perspective view of the north and west elevations of rear/side addition**
