# HERITAGE IMPACT ASSESSMENT

1420 CHARLESTON SIDEROAD, TOWN OF CALEDON, REGIONAL MUNICIPALITY OF PEEL, ONTARIO

**CBM AGGREGATES**

PROJECT NO.: OCUL2216

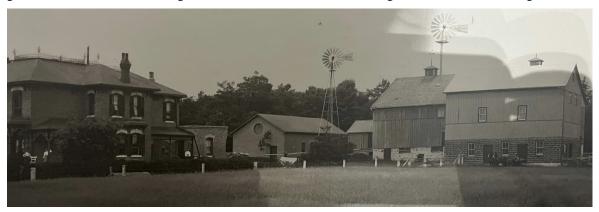
Plate 1: Historical photograph of the house and outbuildings, date unknown.

An undated photograph of the farm complex shows the house and several outbuildings, likely during the first decade of the 20th century (Plate 1). The two-storey brick house is seen as fully constructed, including a rear tail or summer kitchen. To the rear of the house is a single storey brick building with a gable roof and circular gable window. The stone foundation barn is partially visible at the rear of the property, clad with wood and featuring a gable roof with two cupolas and a weathervane. A smaller timber framed structure is seen in the background, between the barn and the brick outbuilding which appears to be of the same style and construction as the barn. It is unclear if this structure is freestanding or part of the barn. Obscuring the barn, to the north of the house, is a two-storey carriage house with stone foundations, brick masonry on the ground floor, likely load bearing, and the upper storey clad in wood, with a gable roof. The windows of the ground floor are accented with stone segmental arch heads and lug sills.

The barn, which remains today as foundation ruins, is visible in the early 20th-century photograph that shows the barn as a timber frame structure with a gable roof. This style of barn was being replaced across southern Ontario by those built with a gambrel roof in the first decade of the 20th century (McIlwraith 1997). In this case we know from the engraving on the stone foundation that the barn dates to the first decade of the 20th century, at the latest.

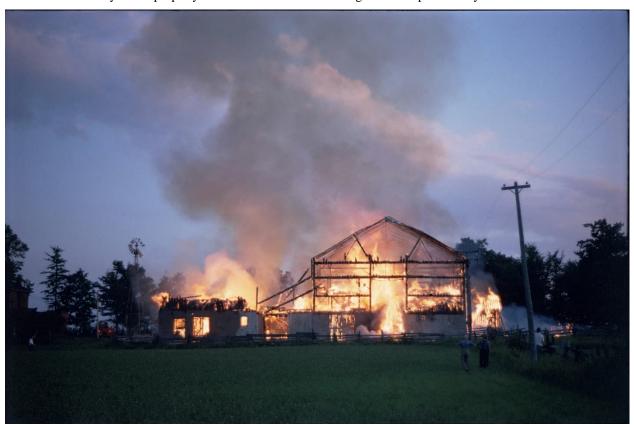
Plate 2: Barn fire, July 1964.

The barn with stone foundation, visible in Plate 1, burned down in July 1964 (Plate 2). Oral history from Carol Coulter Crews, who lived on the adjacent farm at 18473 Main Street, notes that only the tractor was saved from the Cameron barn fire, as it was in the garage (Caledon Heritage Foundation 2024). John H. sold the property in 1968 and died in 1973 (Find a Grave 2020). The property changed hands several times in the decades followed the Cameron's ownership before being sold to the current owner, St. Marys Cement Inc. in 2022. It appears that the Study Area was severed from the surrounding agricultural fields in the 1970s, as a reference plan dated May 20, 1976 shows a survey of the property boundaries in the same configuration as present-day.

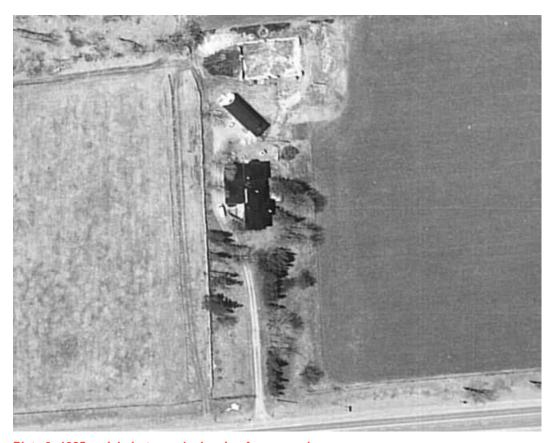
Plate 3: 1985 aerial photograph showing farm complex

An outbuilding at the rear of the Study Area is northwest of the house. It is oriented east-west and is wood clad with a gambrel roof (Plate 13). Based on aerial photographs and topographic mapping this building was constructed between 1973 and 1985 (Figure 6 to Figure 9 and Plate 3).

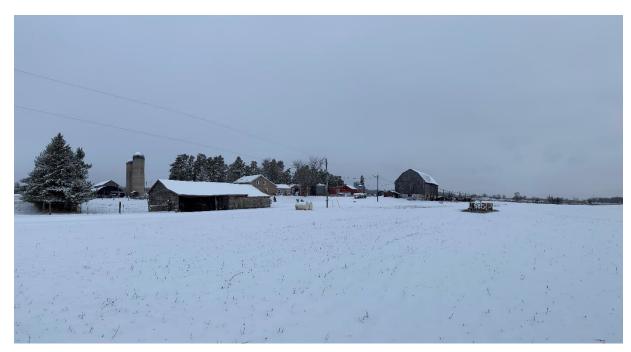
Plate 5: Farmscape at 18501 Mississauga Road

The properties in close proximity to the Study Area (18501 Mississauga Road, 18667 Mississauga Road, and 18772 Main Street) are rural agricultural and all listed on the Town's heritage register (Plate 5 to Plate 8). Historically, these properties were all granted to and owned by various members of the Cameron family in the 19th century.

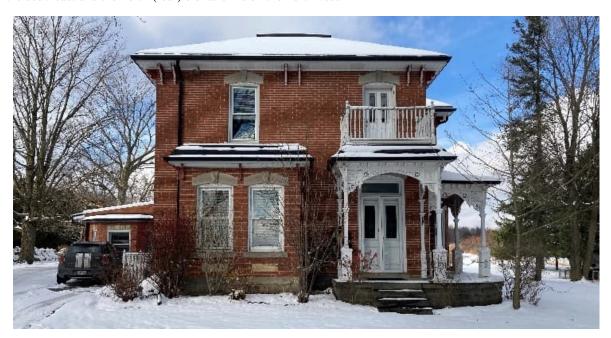
Plate 16: South (front) elevation, facing Charleston Sideroad

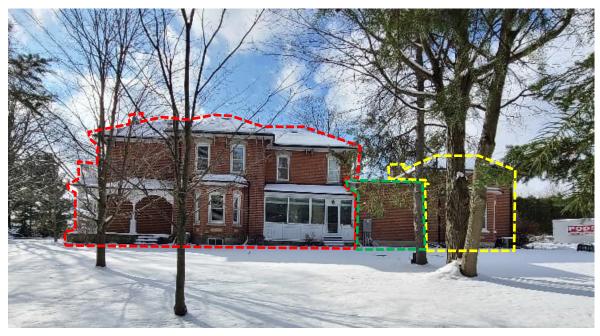
Plate 17: East elevation showing the original house (outlined in red), rear tail (outlined in green) and rear/side addition (outlined in yellow)

The farmhouse is composed of three elements: the original main block, a rear tail, and the rear and side addition on the north and west sides of the house. These are described individually in the following subsections. The four elevations of the structure are shown in Plate 16 to Plate 20. The house is oriented in a northwest to southeast fashion but for ease of description it is described in a north-south orientation where the south (front) elevation is on the southeast and the north (rear) elevation is on the northwest.

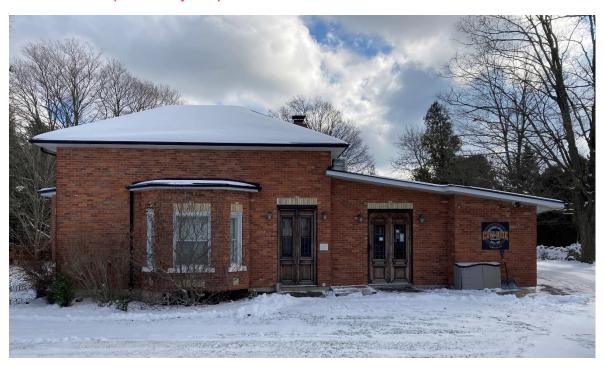
Plate 18: North (rear) elevation (rear and side addition visible only)

The rear and side addition is comprised of two segments, both built in modern red brick laid in stretcher bond on cement block foundations. Based on their similar style, materials, and condition, these rear and side structures were likely constructed at the same time and so are discussed together. The rear structure has a square footprint and hipped roof while the side portion has a shed roof and extends along the west sides of the rear addition, rear tail, and main block (Plate 41).

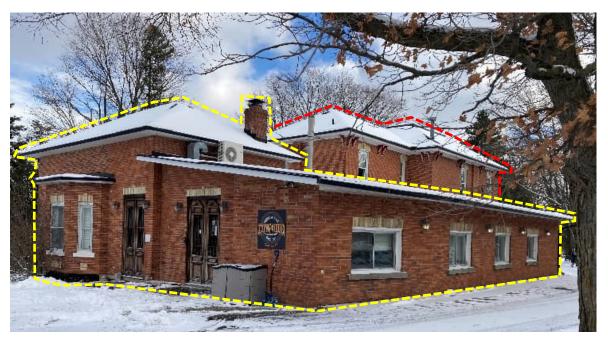
Plate 19: Oblique view of north and west elevations of rear and side additions (outlined in yellow, original main block is outlined in red)

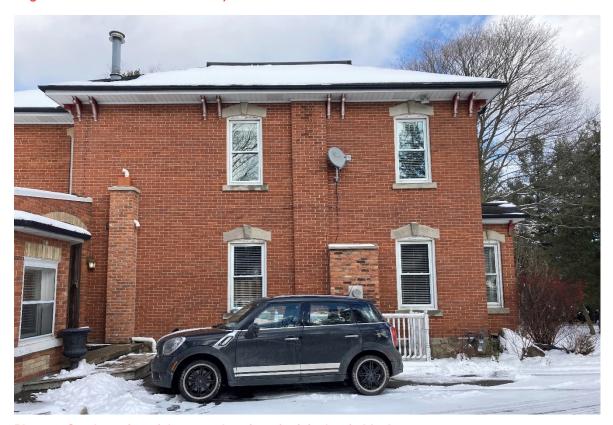
Plate 20: South portion of the west elevation of original main block

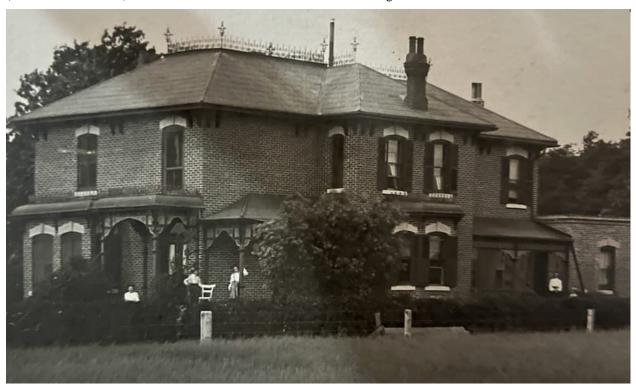
Plate 21: Detail of the late-19th to early 20th-century photograph of the house.

The historical photo of the house shows at least three chimneys on the main block. An internal chimney on the east elevation and external chimneys on the north and west elevations are no longer extant (compare Plate 21 to Plate 20, Plate 29, and to Plate 39). At the time of the field review, the west elevation features the original west elevation chimney, as well as two external vents that extend the height of the first storey and are constructed of brick masonry (Plate 20 and Plate 38). Neither of the two external vents date to the original construction of the main block.

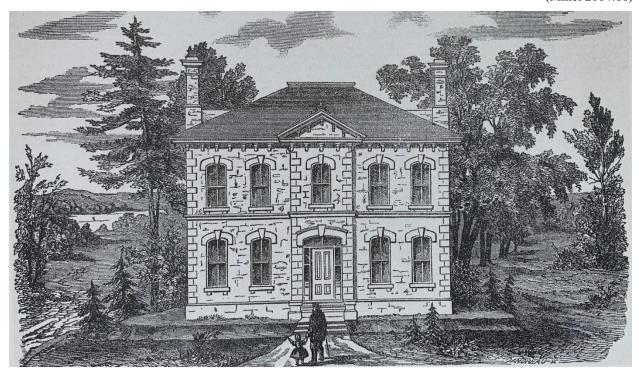
Plate 47: Italianate style model house from 1865 The Canada Farmer Journal (Blumenson 1990)

One of the most common Italianate forms was the simple square hipped-roof house. It was generally rectangular with the narrow side fronting the street. The façade was usually symmetrical, except for the front door, placed to one side and forming a side hall plan.

The house in the Study Area displays some architectural features characteristic to the Italianate style, such as the simple form with hipped roof, symmetrical façade with offset entrance, projecting frontspiece on the side elevation, projecting eaves with brackets, brick and stone accents (window cornices, sills, foundation) which create a dichromatic effect, carved stone window heads with keystones, and wooden arcaded porch.
