# HERITAGE IMPACT ASSESSMENT

18667 MISSISSAUGA ROAD, TOWN OF CALEDON,  
REGIONAL MUNICIPALITY OF PEEL, ONTARIO

PROJECT NO.: OCUL2216  
DATE: JULY 28, 2023

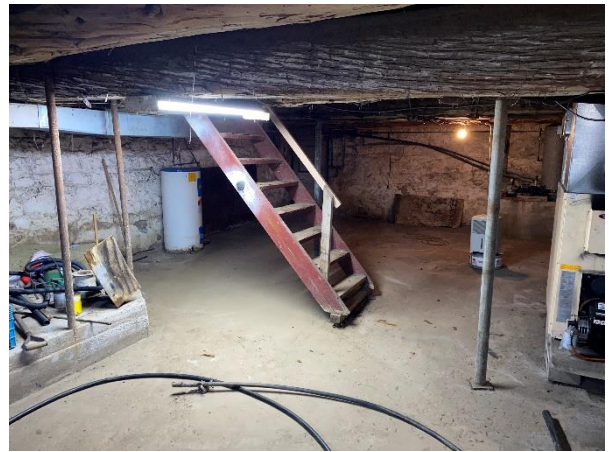
The basement is an open, rectangular room that encompasses the footprint of the original main block (Plate 30 and Plate 31). The entrance to the basement is via a stairwell located in the hallway on the west side of the main block. The floor is poured concrete and the random rubble walls of the foundation have been parged (Plate 32 and Plate 33). The floor joists are visible and consists primarily of logs which were hand-hewn on the top and bottom to provide a flat surface but otherwise left in the round, some with the bark still intact (Plate 34). There are ten hand-hewn log joists spanning the entirety of the main block, with five on each side of the staircase. A singular log joist has been squared on all sides and cut to accommodate the staircase (Plate 35). Later, metal floor joist jacks were added to support the framing. The main block's plank subflooring is visible between the log joists (Plate 36). There is a single basement window on the south elevation. The window has sawn wooden frames and is set into the parged stone foundation. Concrete has been hand applied between the window frames and stone foundation. The window has a hand-hewn timber lintel. A sawn piece of wood sits atop the lintel and plexiglass has been attached on the interior. (Plate 37).

**Plate 30: Basement of the farmhouse**

**Plate 31: Basement of the farmhouse**

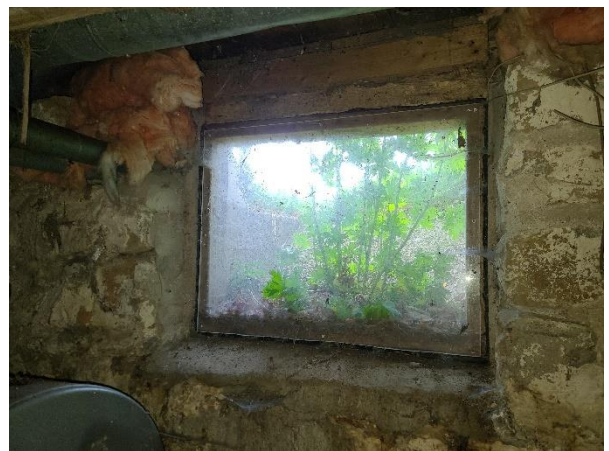
**Plate 37: Basement window**

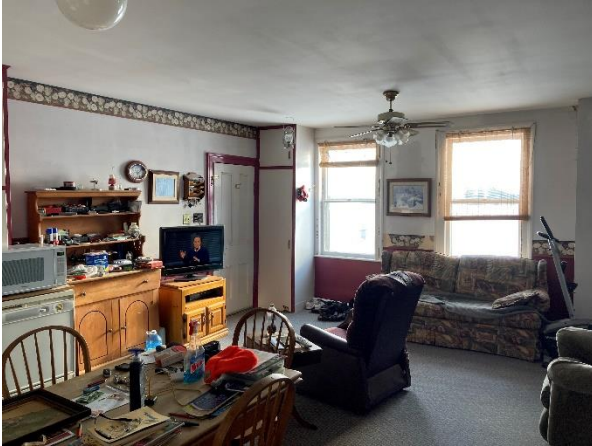
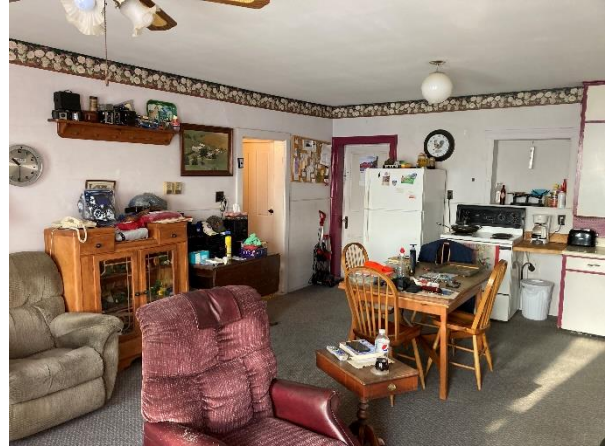
The kitchen is located in the north half of the main block (Plate 38 and Plate 39). Wood doors and trim appear to be original and are in good condition. Cast floor grates are also likely original to the house or very early additions (Plate 40). Carpet covers the floor. The frame for an original window opening on what would have been the original west elevation has been converted into a nook, likely at the time the west addition was constructed (Plate 41). Two one-over-one sash windows are located on the east wall of the kitchen on what would have been the original front elevation of the house (Plate 42 and Plate 43).

Plate 38: View across kitchen towards northeast corner of the house

Plate 39: View across kitchen towards southwest corner of the house

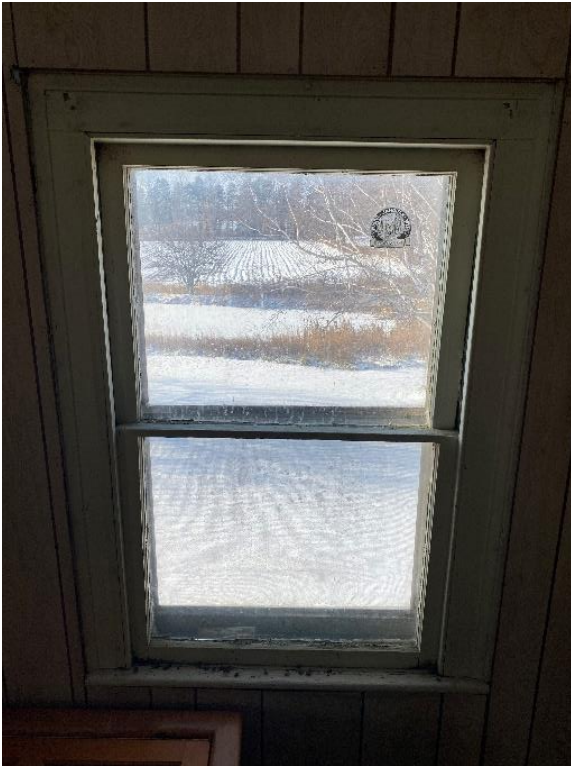
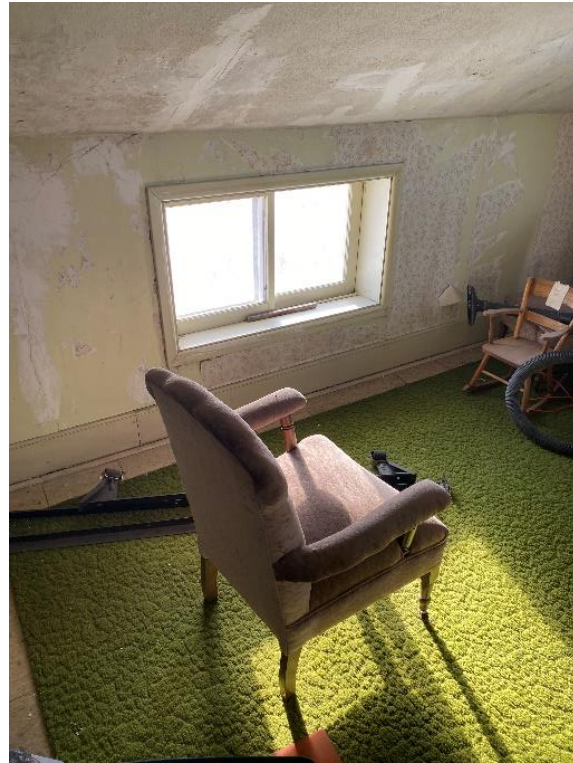
The southeast room is decorated with faux wood panelling and wallpaper on the walls and carpet over linoleum flooring (Plate 48). Both windows (of the north and west elevations) appear to be original and in good condition (Plate 49 and Plate 50). Cracks and subsequent repairs are evident in the plaster of the ceiling (Plate 53).

**Plate 49: Detail of south window of southeast second floor room**

**Plate 50: East window of southeast second floor room**

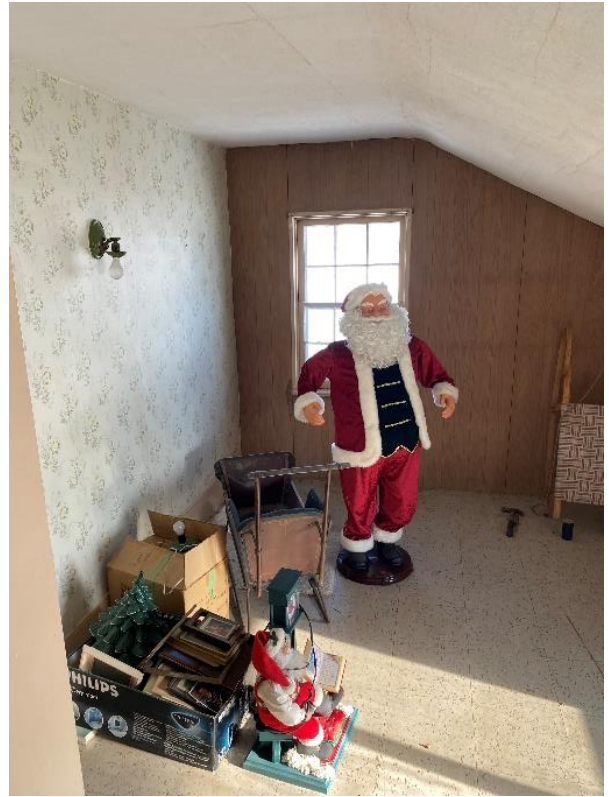
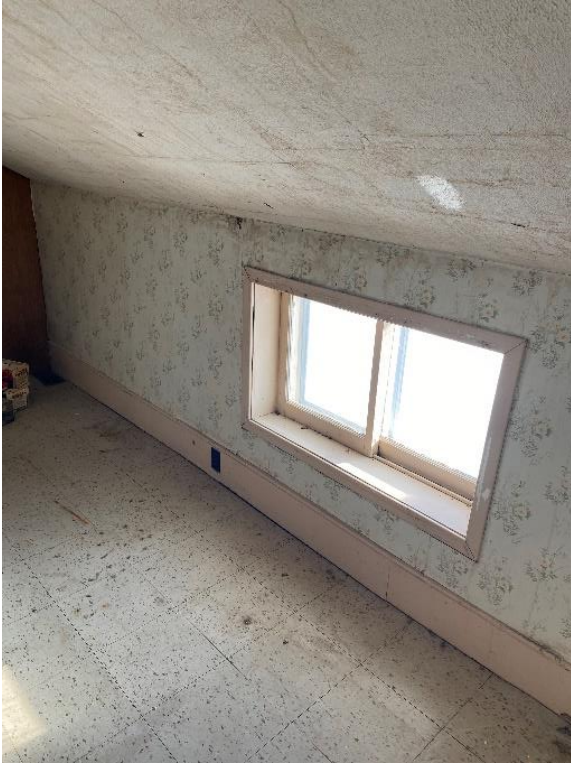
The northeast room appears in much the same state as the northwest room, with the exception of the carpet covering the linoleum flooring (Plate 54 and Plate 55). The door to this bedroom is constructed of vertical boards (Plate 56).

**Plate 54: Northeast room of second floor**

**Plate 55: Detail of east knee wall or "bellyflop" window of northeast room**

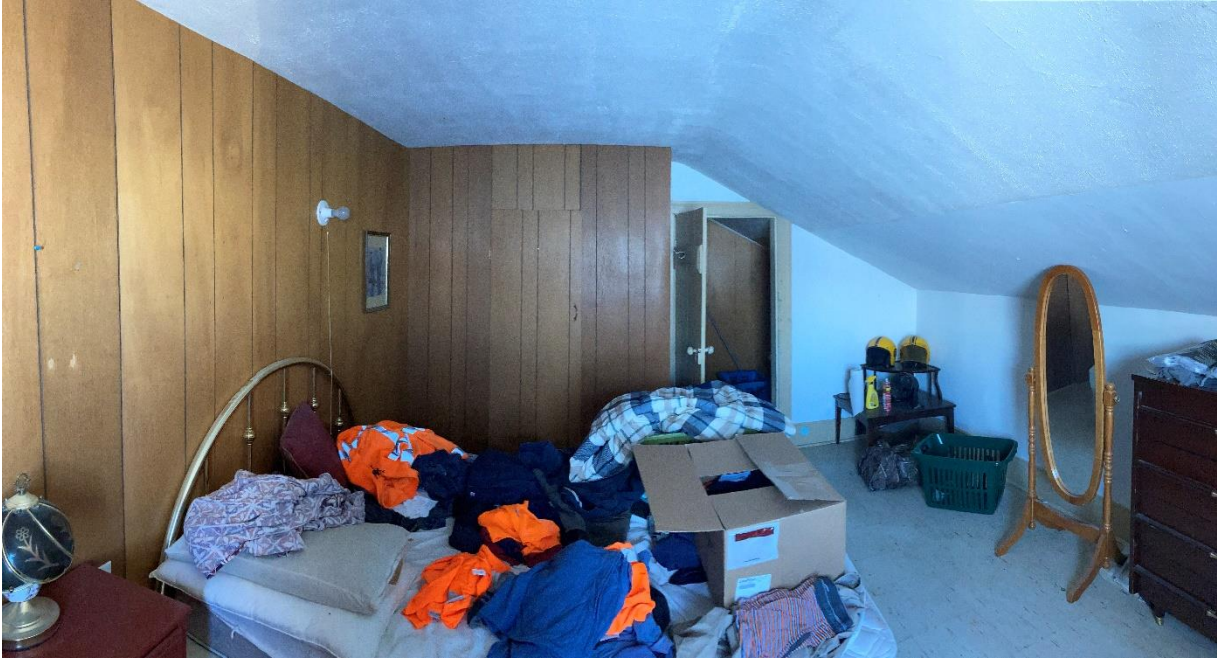
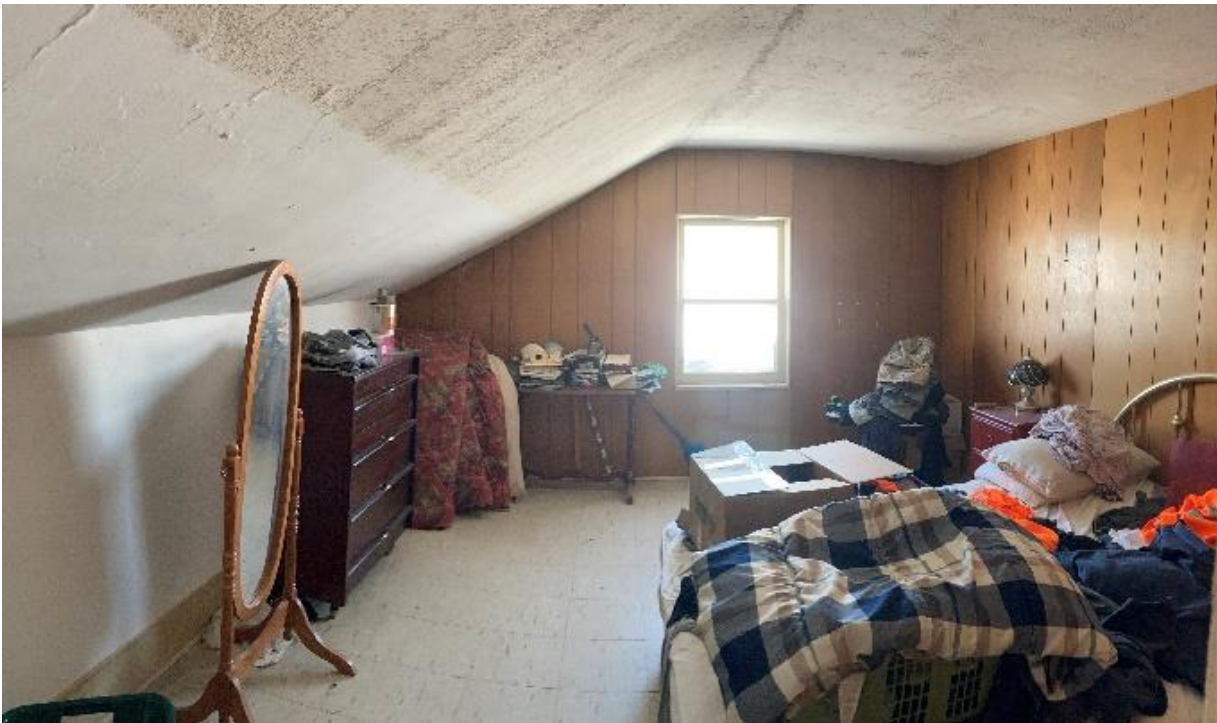
The northwest room has linoleum flooring and wood panelling on the walls and wide baseboards (Plate 58 to Plate 60). The door to this bedroom is constructed of vertical boards (Plate 61 and Plate 62).

Evidence of deterioration is present throughout the second floor of the main block. Peeling paint and wallpaper as well as cracks in the plaster of the walls and ceilings were noted in all rooms.

Plate 58: Northwest room of second floor

Plate 59: Northwest room of second floor
